ARCHAEOLOGICAL DESTRUCTION IN TURKEY

YEAR 2008 PRELIMINARY REPORT

MARMARA REGION - BYZANTINE PERIOD
APRIL - SEPTEMBER 2008

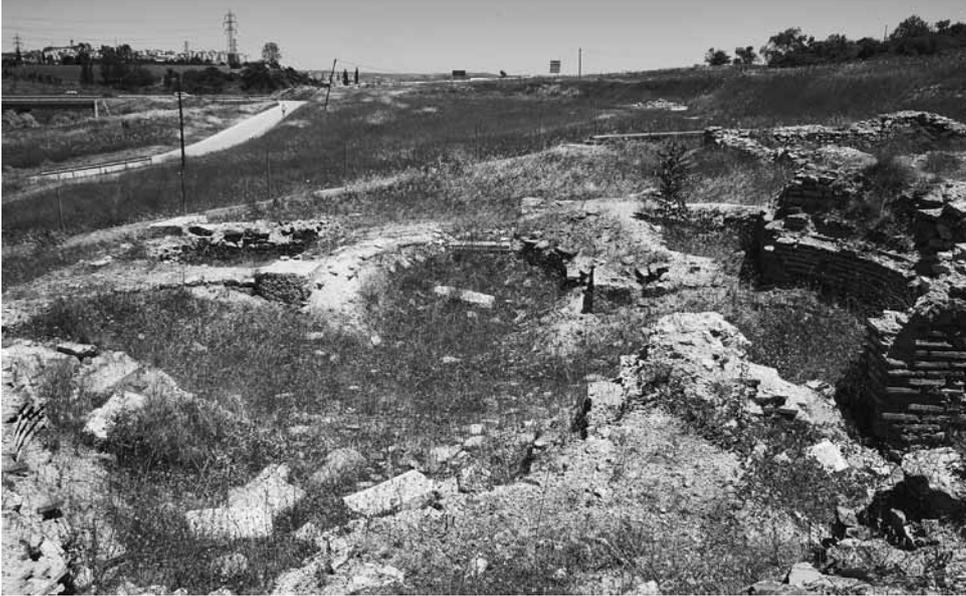
Northern Necropolis of İzmit: The building complex at the Orhan Quarter to the north of İzmit is one of the most important ancient cemeteries in the region with public type of graves from the Late Roman and Early Byzantine Periods. Dated to the 4th century, they are now under the threat of a ring road linking to the İstanbul-Ankara highway, and of one of the most rapidly developing quarters of İzmit known as Turgut Mahallesi.

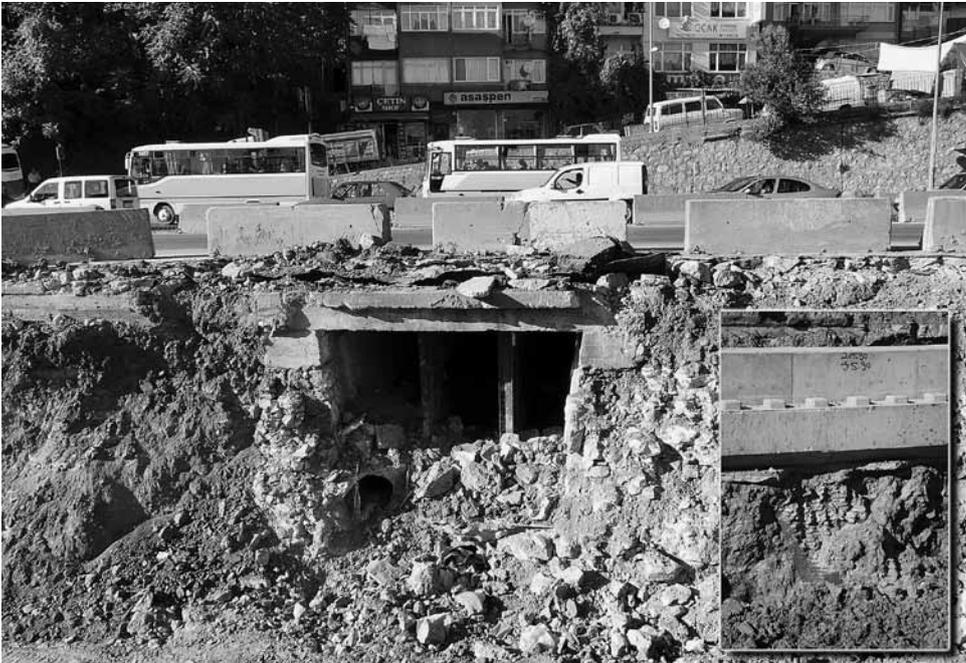
City Walls of İzmit: First erected by Nicomedes I (278-250 BC), founder of İznik (Nicomedia), the extant sections of the walls bear traces of four main periods from the 4th century till the 15th century. The sea walls were destroyed and demolished during the construction of the D-100 motorway in 1995. Recently, the construction of an underpass at the SSK Junction revealed that re-exposed walls extend for approximately 2 km. At present these fortifications, older than 2000 years, still traceable at some sections, will be demolished during these road construction activities, and the distance between İstanbul and Ankara will be shortened for 2 minutes more by the highway.

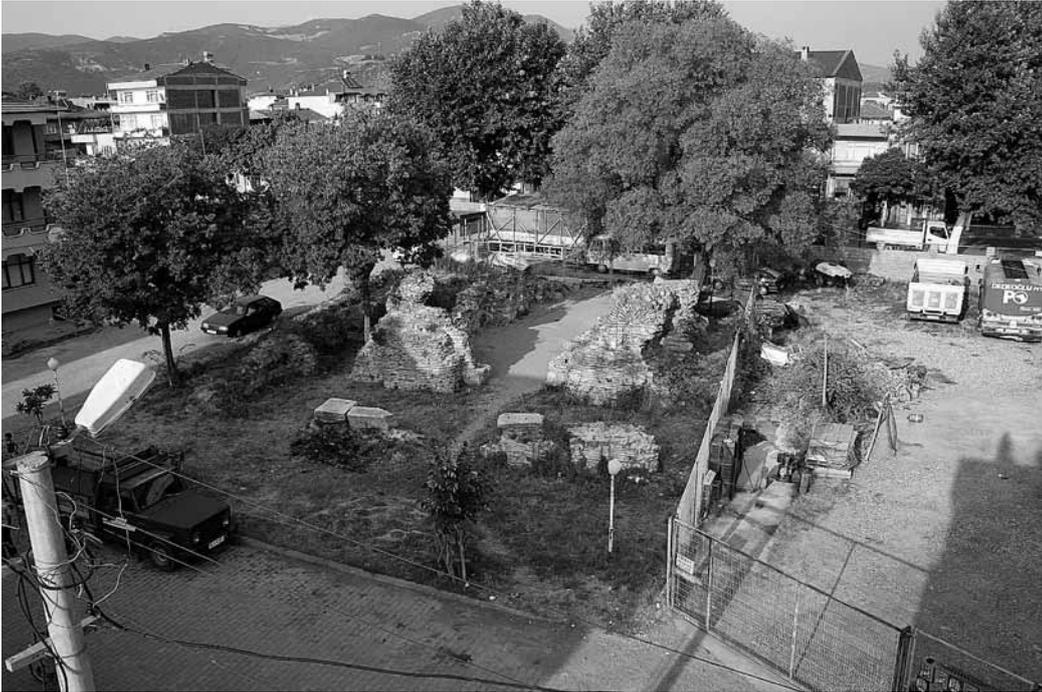
Church Ruins 2 at İznik: Unfortunately the destiny of İznik Church 2, dated to the 11th century is not any different than the other churches in İznik. The southern section has been obscured by the parking lot, the northern section by the road, and the eastern section by the shops. On top of it, trees planted by local authorities as if they are implying that “we destroyed all, but at least it looks nice”... What remains from the church is only a wall of one or two rows, and a stone of one or two pieces... which also will be lying under the parking lot very soon.

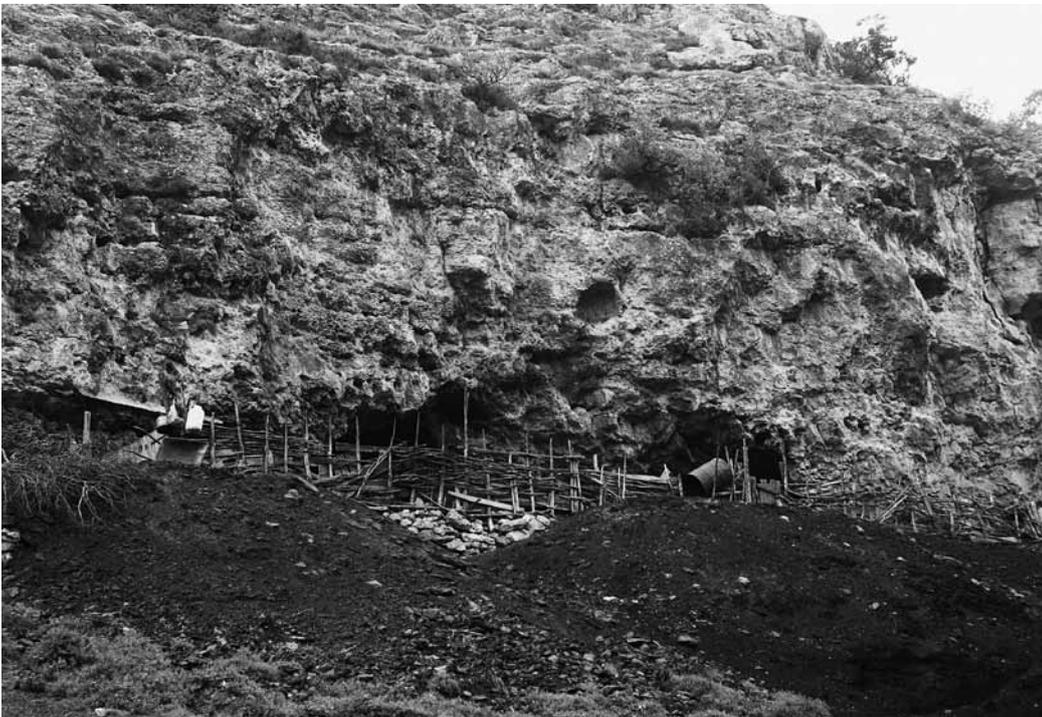
Direkli Cave Monastery: This cave monastery situated near Vize is a complex entirely carved into the rocks. It consists of many rooms, and a large church, but now it shelters stray dogs and goats. It is almost impossible to access the monastery due to inhospitable dogs and owners of the shelter, which is full of goats anyway.

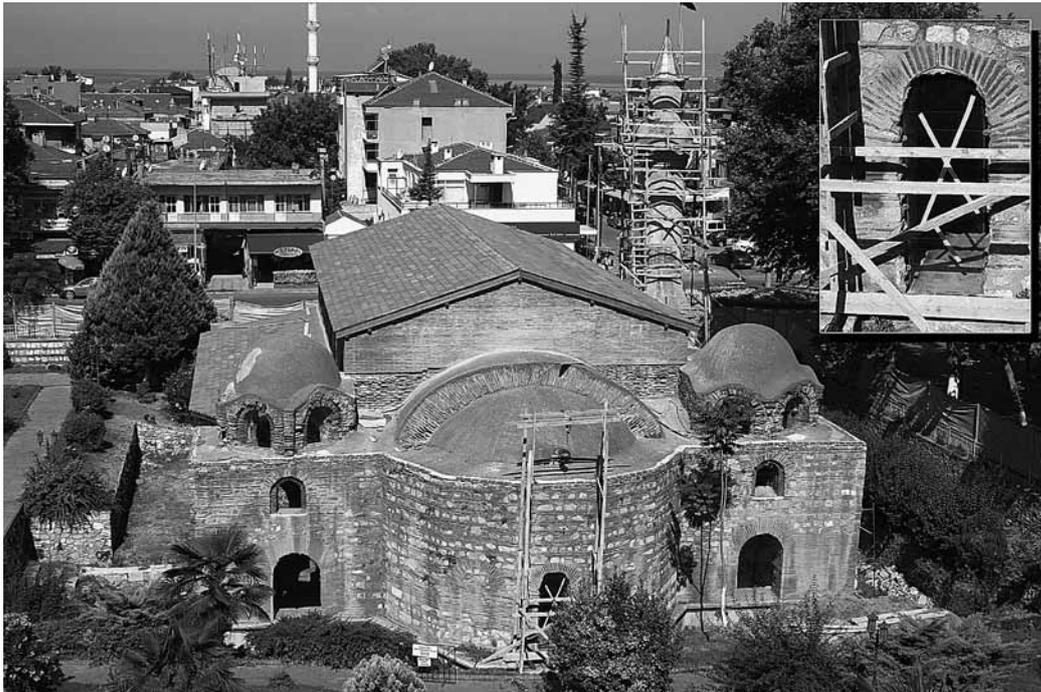
Ayasofya Church of İznik: Ayasofya, which is situated at the district center of İznik, has been completely modified due to recent interventions by unexperienced, ignorant and unconscious authorities and contractors in such a way that almost nothing has been left from its original identity and historical value. With its collapsed walls, high tile hipped roof, flaked off domes, openings closed by glass, minaret built with concrete, electrical wirings and water pipes...

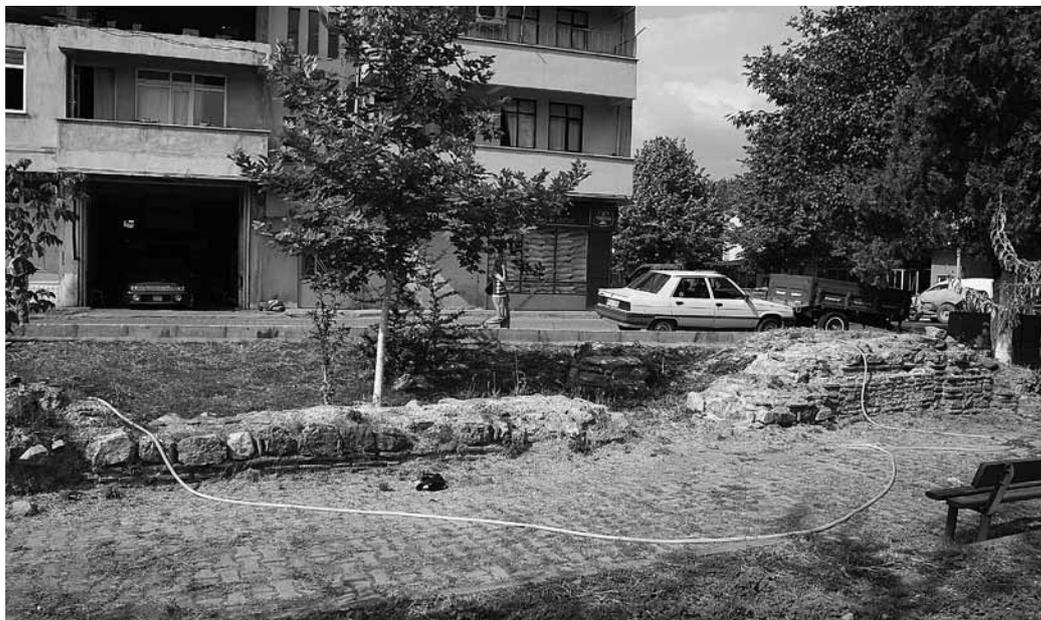
Church Ruins 1 at İznik: Situated near the İstanbul Gate at İznik, only the southern section of this 11th century church is still extant. Part of the church had been demolished during the construction of the Kumbaşı Street while the remaining parts were destroyed during the enlargement activities of the same street in 2006. The environs of the church have been converted into a public park, with trees planted and benches installed. The architectural elements of the building were used for the park benches. The only thing that is done in the name of preservation of cultural assets nowadays is that: the church is being washed every day!

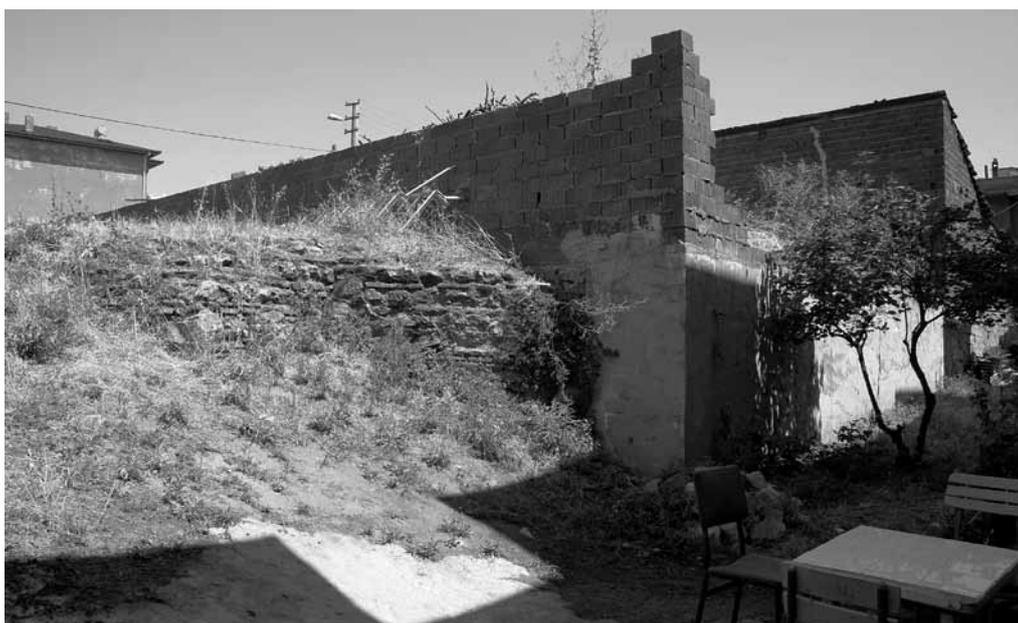
Building Remains at İznik: These remains in the Mustafa Kemal Paşa quarter were excavated between 1988 and 1994. The building complex with a large church was presumably part of the İznik Palace during the Byzantine period. However, many new buildings, including the Bagkur Houses, have been, and are still being, constructed over the remains. Walls to the right and left, scattered fragments of ceramics on the ground, surrounding architectural elements here and there... Apparently the contractor convinced the Preservation Board that the area is free of any artifacts so that they laid the foundations of his modern building right on top of the Byzantine structure.

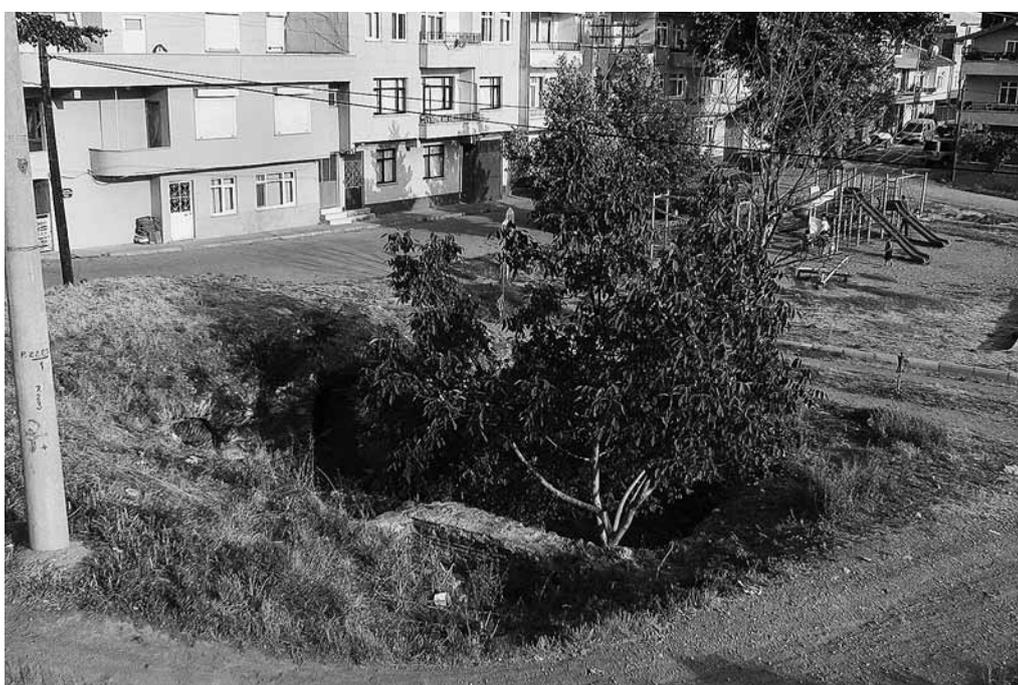
Church Near İznik Theater: Nobody recalls this church, lying to the immediate east of the İznik Theater, as a church anymore. As locals refer to it, it is now “a warehouse, not a church!”. Why? Because until recently it had been used as a warehouse and a barn. On top of it, this building currently filled with garbage up to the roofing, and partly obscured by the newly built roads, is a registered site which had been excavated within the scope of excavations initiated at the İznik theater.

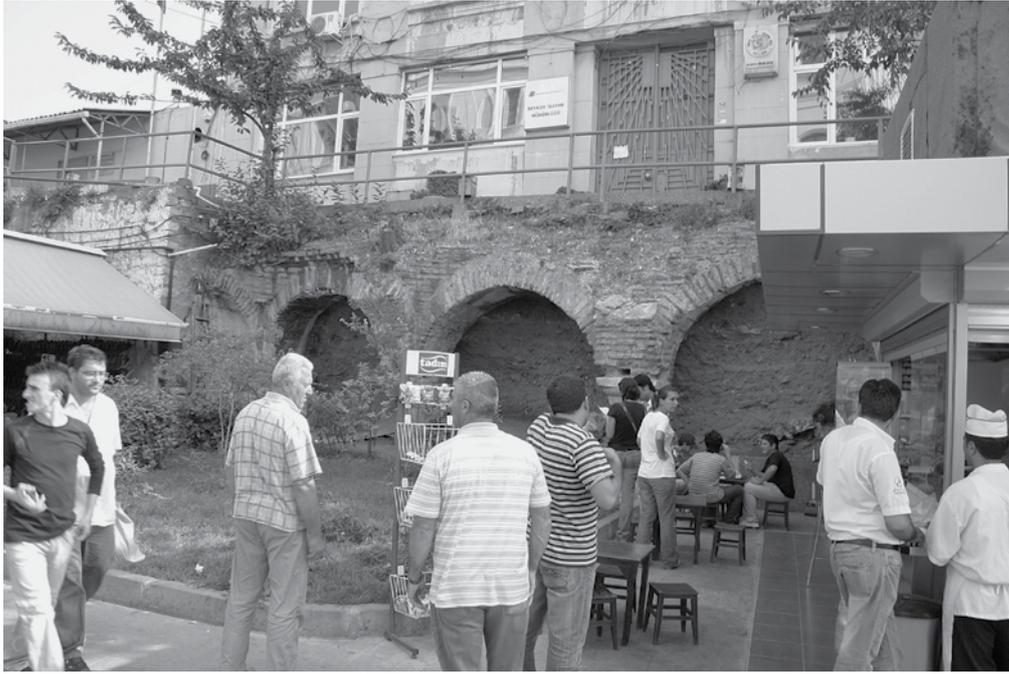
Beyazıt Cistern 1: Two of the three cisterns located in Beyazıt were demolished during the construction of subterranean passage at Vezneciler. One of these can still be seen right below the precinct and electric company at the beginning of the tunnel. The refreshment booth, adjacent to the two extant colonnades of the cistern in east-west direction arranged a seating area inside the cistern for their clients. The roof and the decorated capitals of the cistern that extend under the buildings at upper level, so to speak, invites (!) us to have “döner kebab under cistern”.

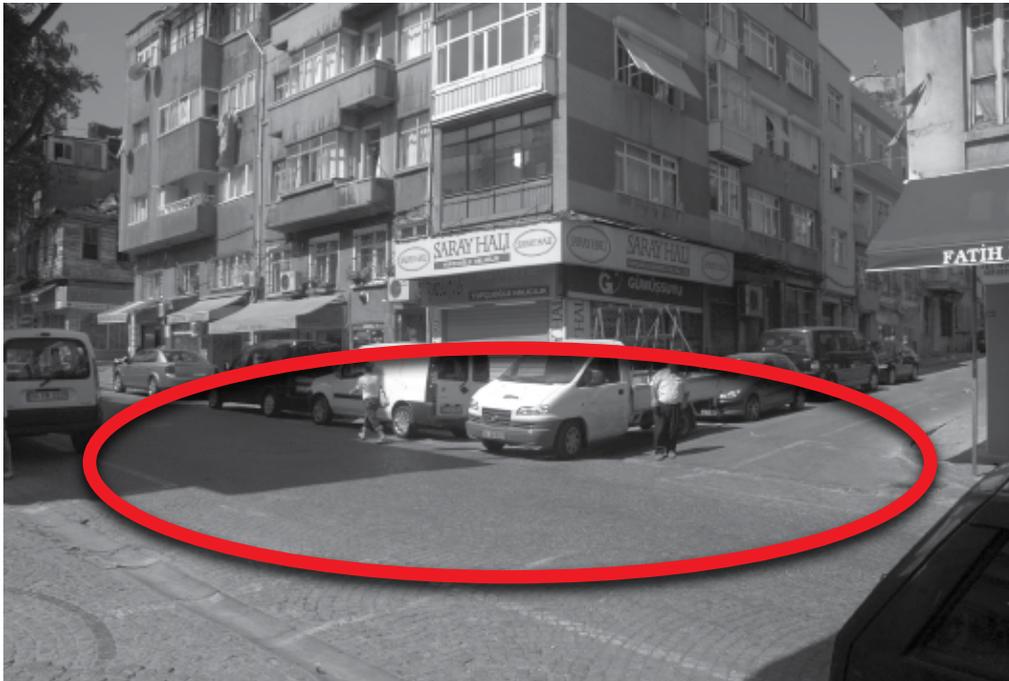
Atpazarı Cistern: This is the intersection of the Mihçılar Avenue and the Keserciler Street in the Kırmaslı Quarter of Fatih District. Here, there is a large cistern, which was unearthed during the installation of telecommunication lines by PTT in 1978. The survey conducted during that period revealed that the cistern measures 35x18 m in dimensions. At present, it has been obscured by many blocks of flats and two avenues.

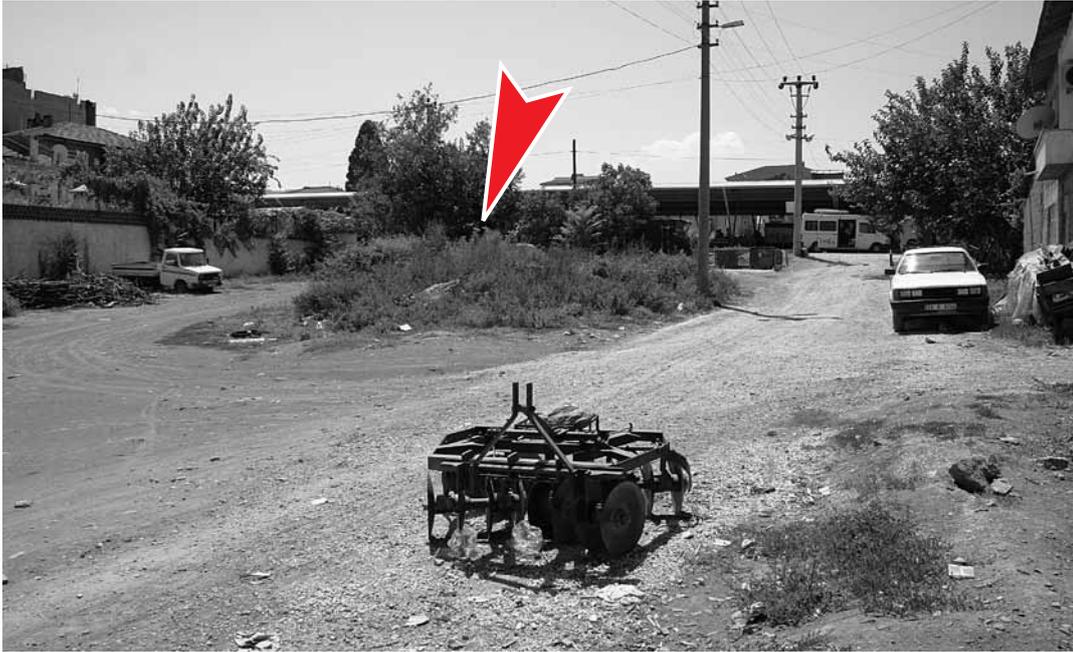
Cistern at Eşrefzade Quarter of İzmit: The cistern is situated on the Eşref Eroğlu Street of the Eşrefzade Quarter. Only a few ruins are available, hardly noticeable among high grass. The process of destruction was initiated in 1972 when the landowner demolished the cistern by bulldozers to construct a road and a building. The cistern doesn't exist anymore. Ironically both the cistern and the quarter were named after the demolisher: Eşrefzade Quarter - Eşrefzade Cistern.

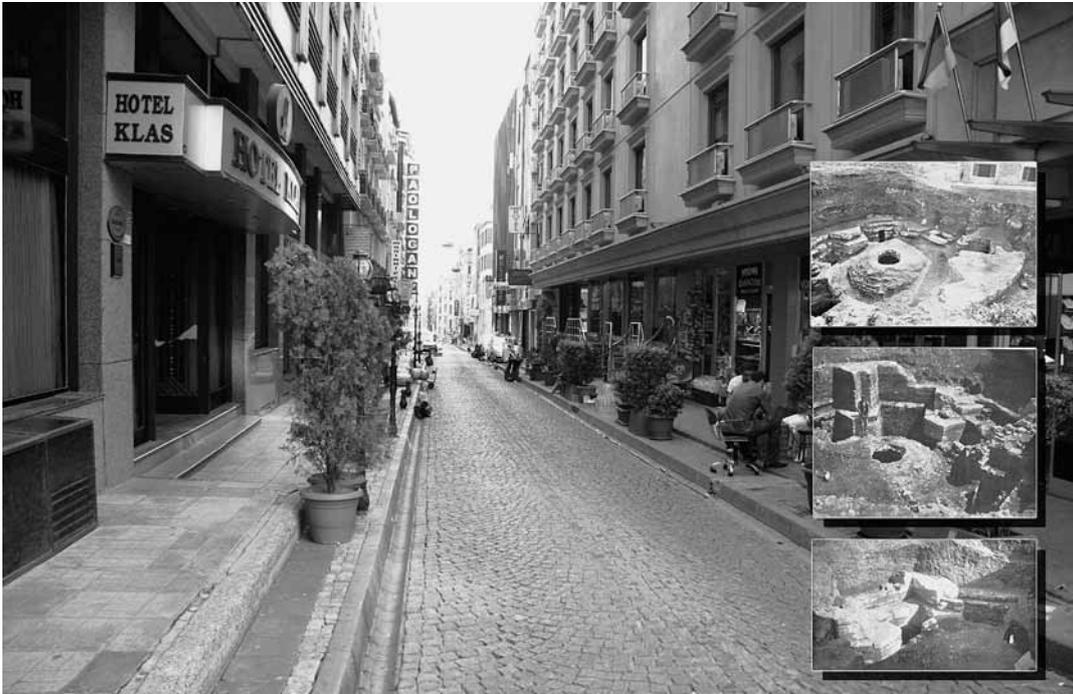
Balaban Ağa Masjid: The excavation of the Balaban Ağa Masjid by Arif Müfid Mansel in 1930 is the first excavation conducted in the İstanbul Citadel by the Turkish scientists. Mansel published his excavation results within the same year. Actually a 5th century Byzantine burial structure, it was converted into a mosque during the 15th century right after the Sultan Mehmed II period. The building suffered grave damage from a fire in 1911, and it was completely demolished during road enlargement works in 1930. This picture shows current view of the place where the small mosque used to be located at, in the Balabanağa Quarter of Fatih District.

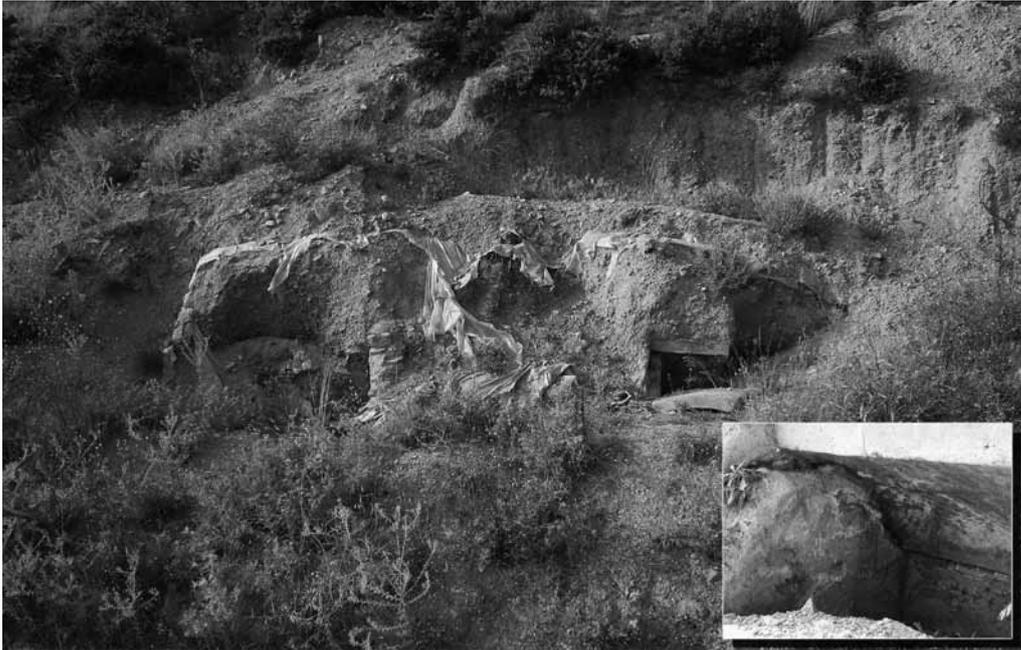
Abdülvahap Burial Chamber: You may look at this picture and think “See, these Byzantines had even plastic graves”, but this not the case here. It is actually our artistic production... three burial chambers under plastic covers and a pile of soil - all decorated with paintings, dating back to almost 1700 years ago. Following the salvage excavations by the museum in 2006, the burial chambers were packed in plastics and covered with a heap of earth. And, then in 2008 State Hydraulic Works threw opened the chambers while trying to open channels! And, later on, thanks to those people highly interested in history (!) the burial chambers dating to the Byzantine Period became like this.

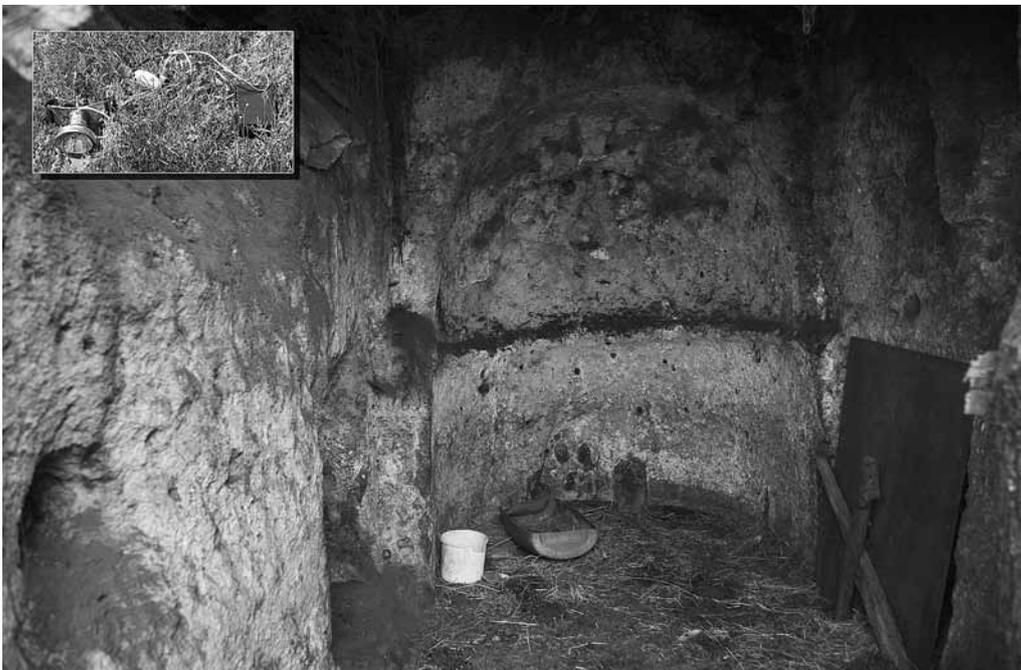
Balkaya Church 1: There are 3 cavern churches in the Kıyıköy District of Kırklareli, which are very close to each other. All three churches are currently used as goat shelters. As seen in this shot, many decorations including the cross figures are destroyed to make sure that the goats are not disturbed in any way! But more harm was given to these churches by robbers than these “ignorant” goats. The small picture shows one of the illumination gadgets used by these treasure hunters.

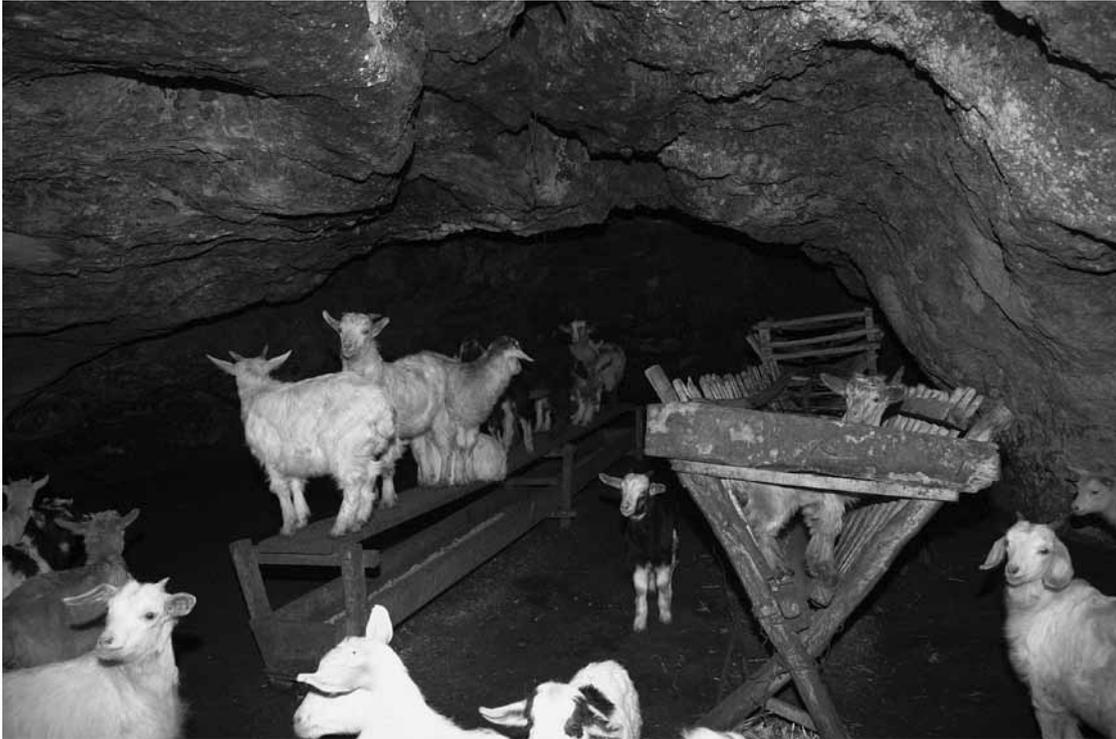
Evrenli Cave: Since it is a very common practice in Thrace, we see that this cave is also used as an animal shelter. With clear traces from the Byzantine Period, it is under the threat of constant destruction, apparently due to lack of another spot in the region to shelter the goats and for the sake of their owner.

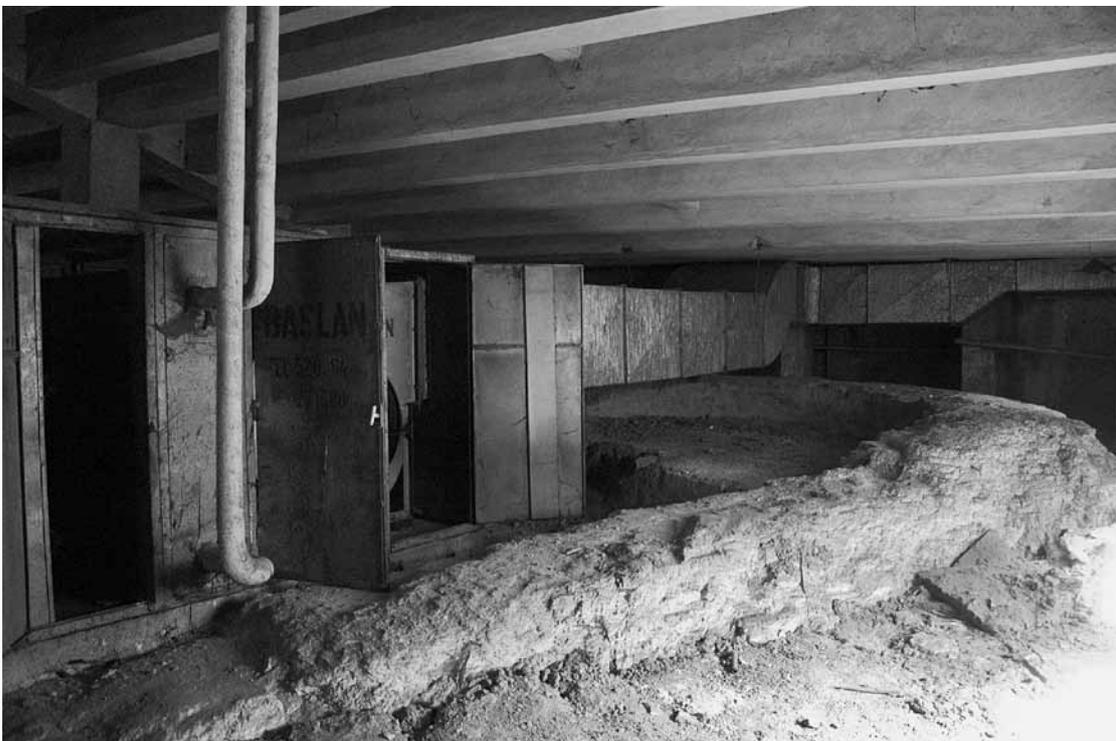
Beyazıt Church D: There are late 11th century church remains on the basement of the Faculty of Sciences of the İstanbul University at Laleli in the section where there are lecture halls and the boiler room. The boiler that is used to heat the faculty building is right at the center of the church. Next to this building, subway construction works continue on the Reşit Paşa Avenue.

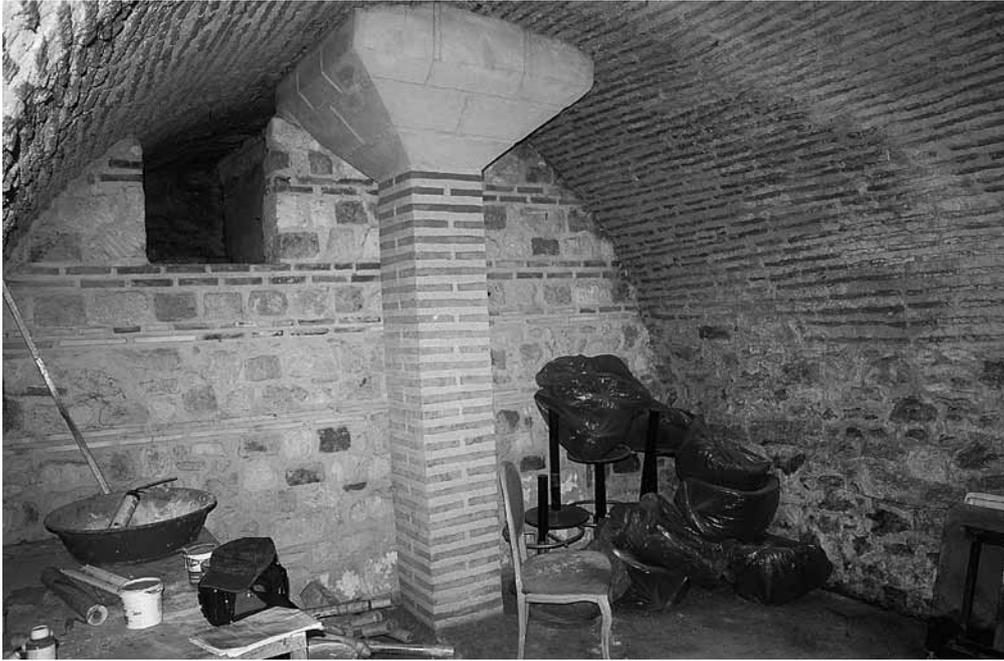
Remains Underneath the Hotel Grand Savur: A large section of the remains unearthed during the construction of the Hotel Grand Savur in the Şehzadebaşı Quarter of Eminönü District in İstanbul in 1990 is currently being used as boiler room of the hotel. The remains, actually extending under the hotel across named the History Hotel, have been already under protection! As seen here, even fake columns were erected at the center to support the building, and the walls were strengthened with concrete. Now the clients of the hotel can sleep in peace in their rooms!

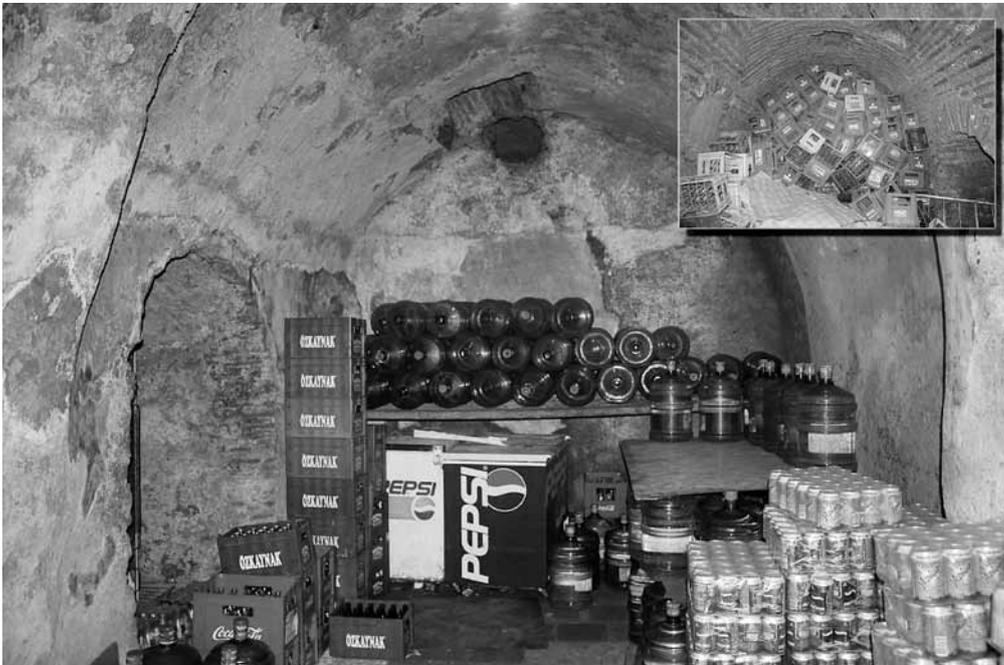
Remains at Acmusluk Street: This magnificent building at the intersection of the Cağaloğlu Ramp and the Cemal Nadir Street in the Hobyar Quarter of Istanbul, is probably part of one of the few extant Byzantine palaces in İstanbul. This enduring structure, of which another section was partially exposed during the construction of an inn nearby, and then immediately demolished in 1965, still supports a huge “inn” even today. It has been currently used for storing soft drink crates. So, if you'd like to have some refreshments from the cellar of the Botaniates' palace ...

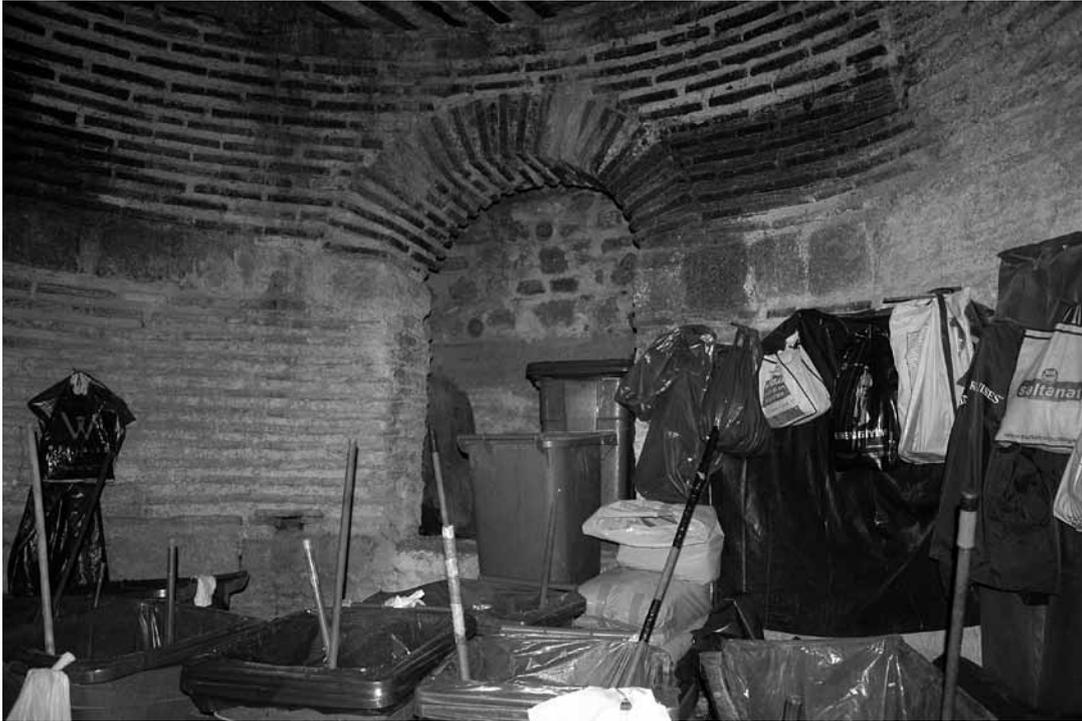
Kalenderhane Mosque: Interior of the chapel dating to the 12th century, lying to the northeast of the Kalenderhane Mosque, one of the most important Byzantine artifacts in İstanbul. This section, which was allocated to a cleaning contractor by the municipality, is no longer a church or a religious building, but a storage facility. Furthermore, a huge iron door was installed at the entrance to keep their invaluable garbage carts and brooms from being stolen.

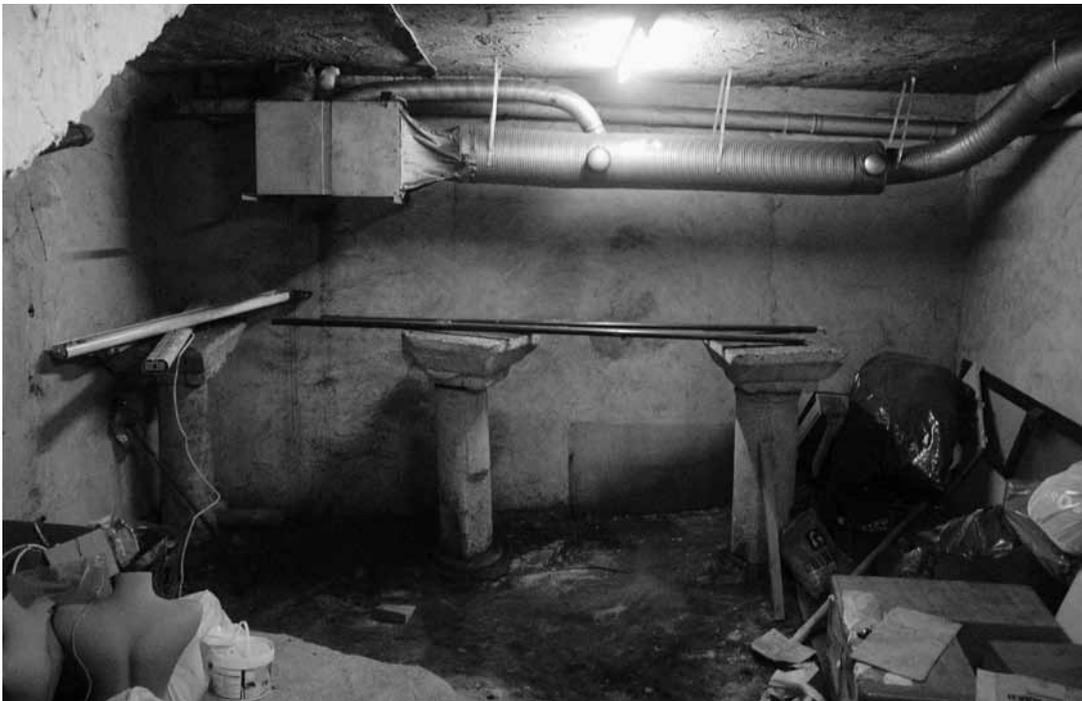
Remains Underneath the Adem Trade Center: These remains can only be accessed through a fabrics shop at the bottom floor of the Adem Trade Center on the Ali Şuaip Street at No. 25 in the Balaban Ağa Quarter of Eminönü District. It is used as warehouse of a trade center which was constructed upon permission immediately after the salvage excavations performed by the Archaeological Museums of İstanbul between 1990-91. The Byzantine architectural elements have been superimposed for decorative purposes to have a “nice” ambience.

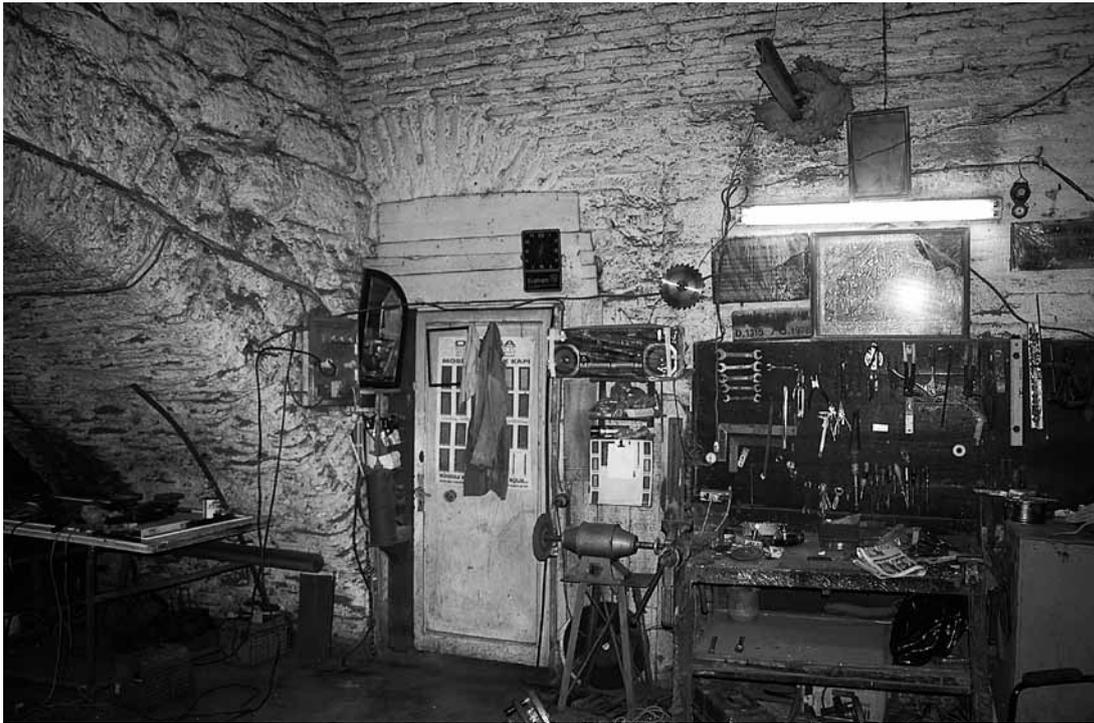
Karpos - Papylos/Menas Church: The church which was dated to the 5th century is situated on the Nafiz Gürman Avenue in the Samatya Neighbourhood of İstanbul. The building was used as a nunnery between the 10th and 12th centuries, and now it houses two shops, an iron workshop and a car wash shop. Believe it or not!

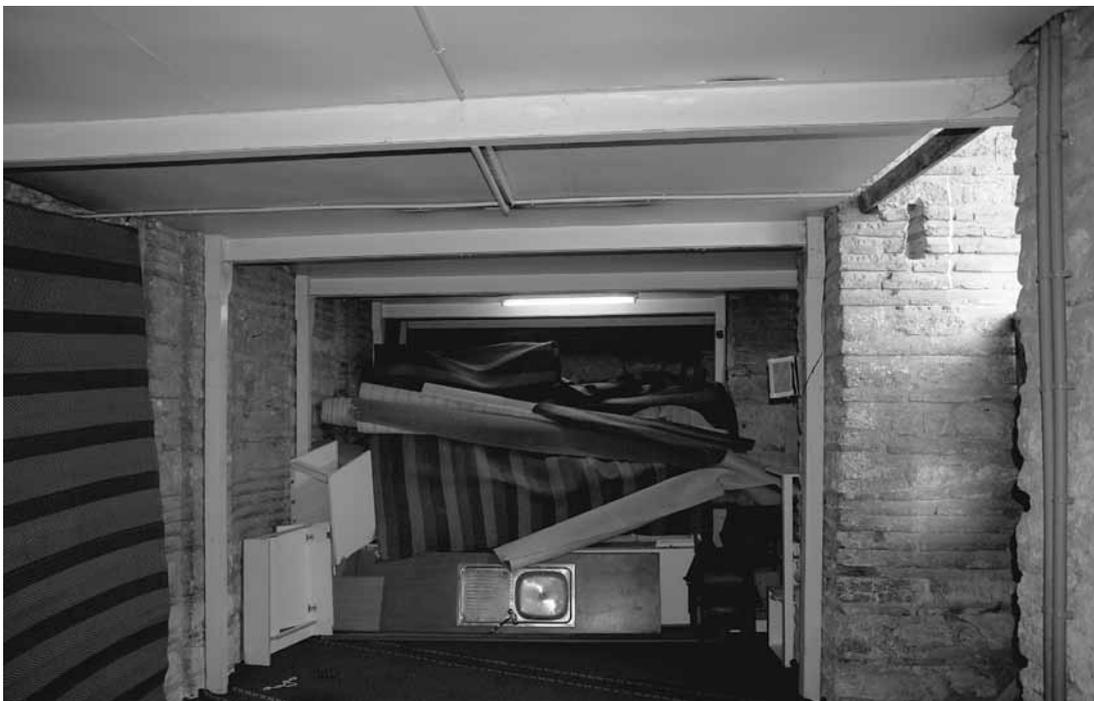
Konstantinos Lips Church/Fenari İsa Mosque: Founded by a Byzantine admiral in 907, it was converted into a masjid in 1496, and then into a mosque in 1636. It is located in the Hasan Halife Quarter of Fatih District in İstanbul, and it currently serves as a mosque. It represents example of the most effective destruction by subsequent occupation in İstanbul documented with its PVC coverings, interior full of carpets, extent of destruction caused by electrical and water pipes.

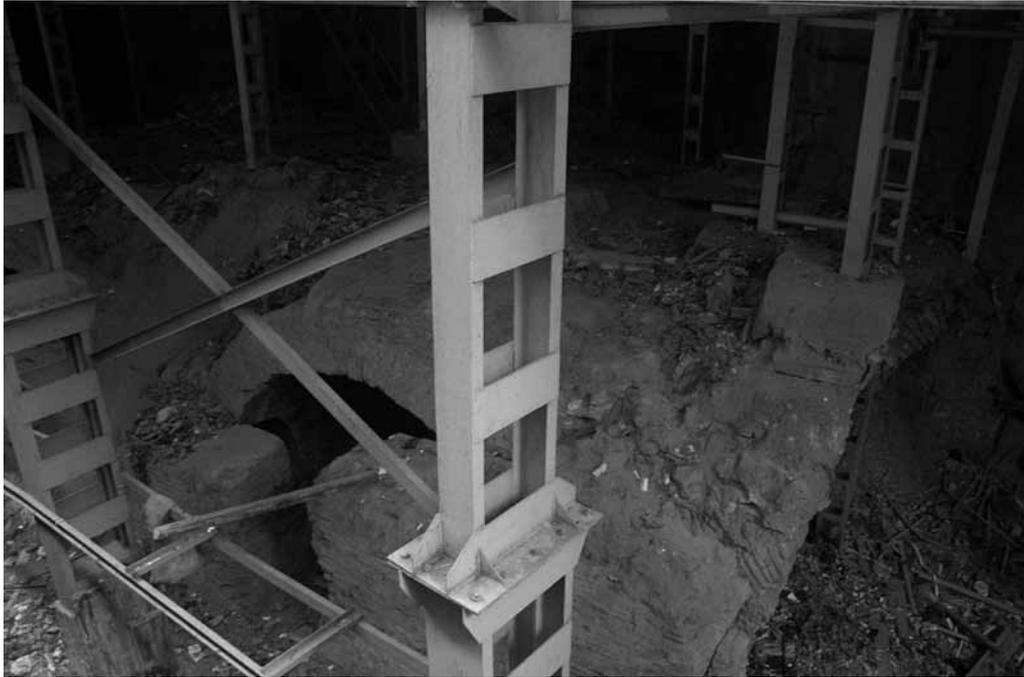
Soğanağa Trade Center: This building underlying the Star Trade Center at Laleli, a neighbourhood which witnessed one of the greatest destructions on the Historic Peninsula, probably dates to the early Byzantine Period. No systematic investigation was carried out on the remains, which were exposed during the construction of the center in 1996-97. Suffering under steel pillars erected to support approximately 50 shops inside the trade center, this Byzantine structure extends under the adjacent trade centers and shops. And if this is not the perfect example of a terrible destruction, then, what is it?

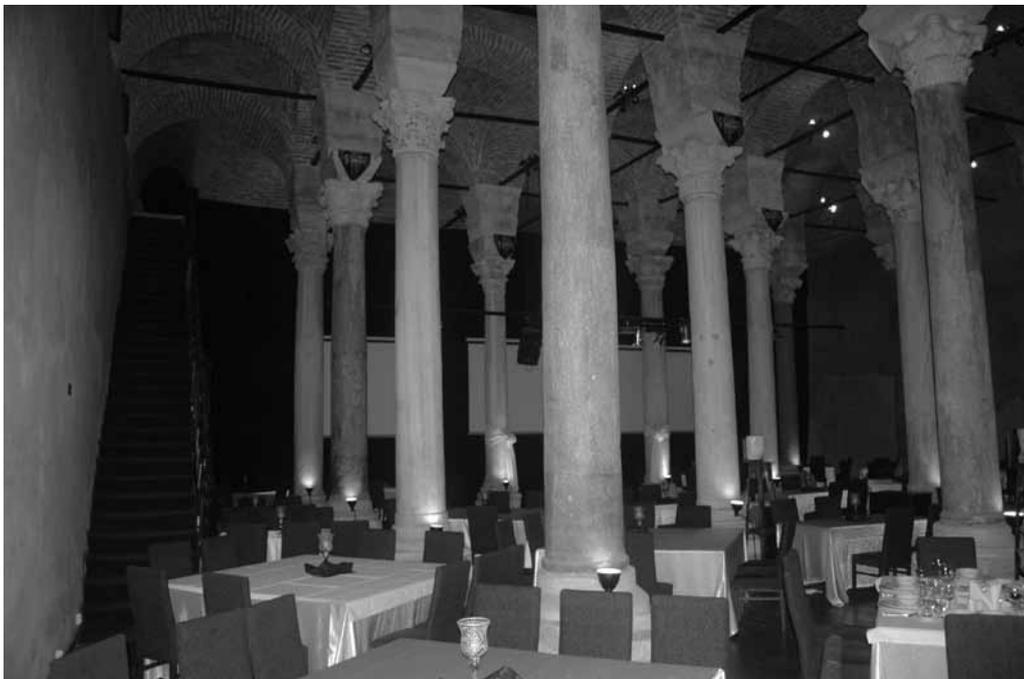
Cistern at Sivasi Tekke Masjid: There is a huge 5th century cistern under the Sivasi Tekke Masjid which did not survive to the present day at the intersection of the Yavuz Selim Avenue and the Ali Naki Street in the Fatih District of İstanbul. Currently known as Sultan's cistern, it is being used as a restaurant, it is nowhere near a cistern anymore, no matter wherever you look at it from...

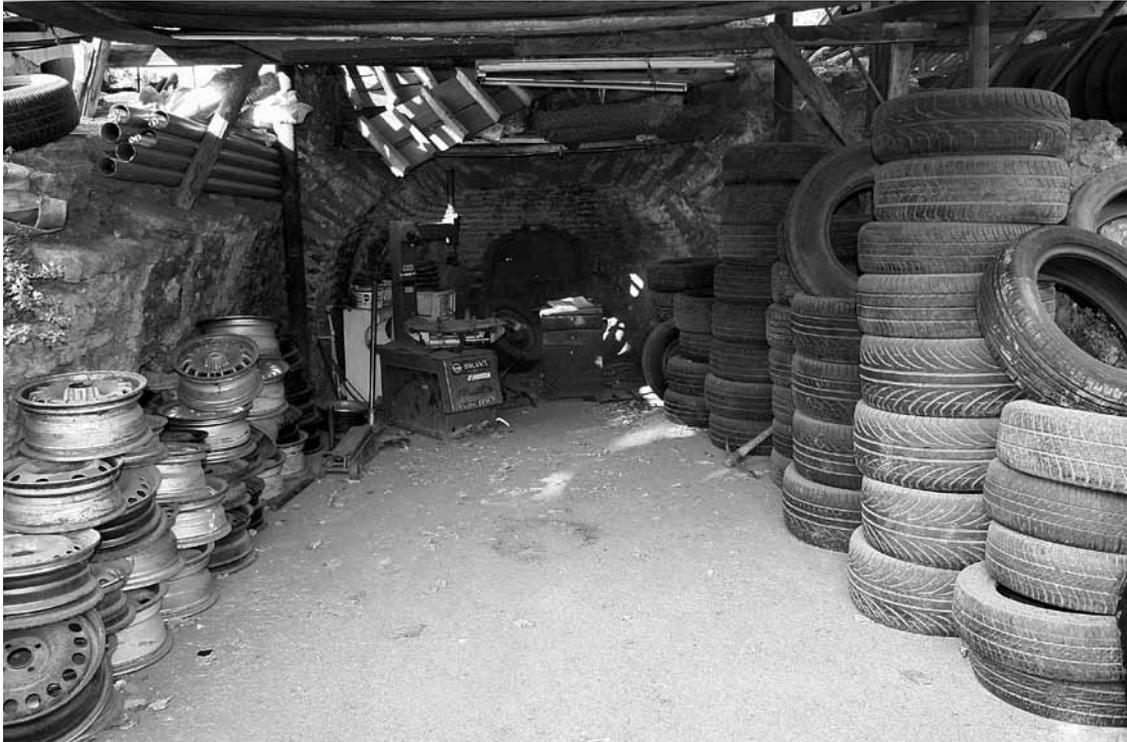
Boğdan Palace: What you see here is part of a 13th century Byzantine church. Located on the Draman Avenue in the Fatih District, the remains are being used as a tyre repair shop at present! See what became of cultural assets. That must be the real essence of preservation! If these remains, which are almost to be completely vanished, are not urgently taken under protection, a little while later another photograph will display nothing else, but the “emperor’s car wheels”...

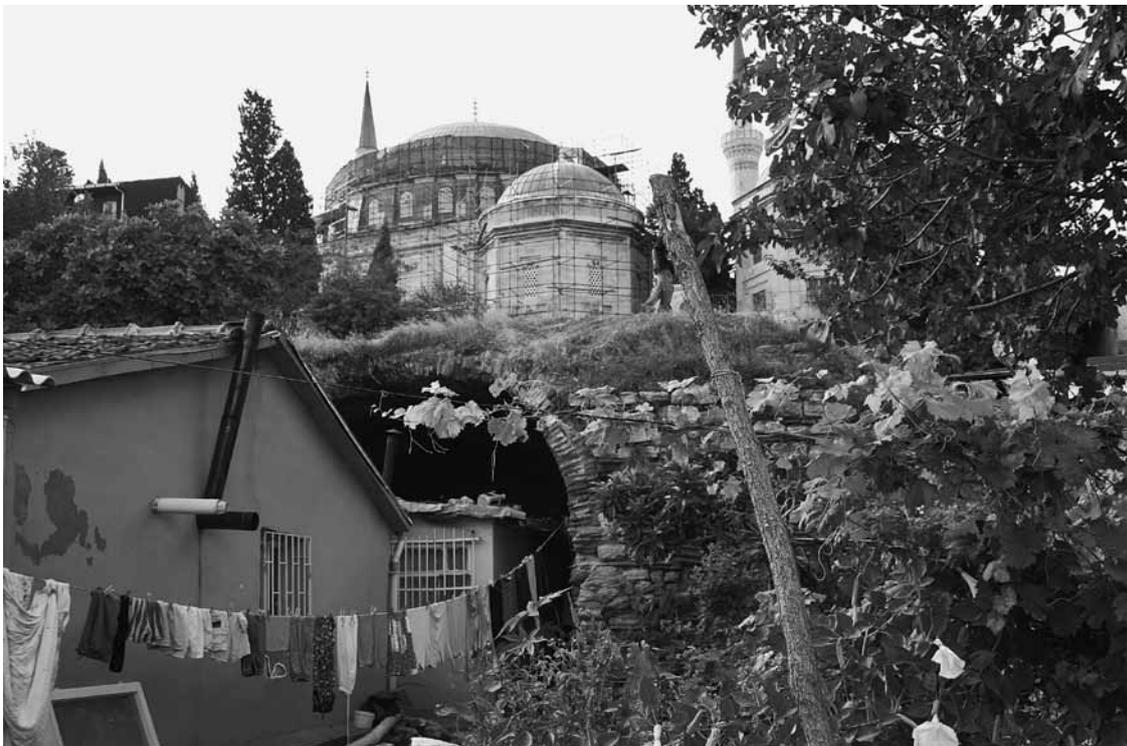
Bonos Palace: The remains near the Islamic-Ottoman Social Complex of Sultan Yavuz Selim in the Müftü Ali Quarter of Fatih District in İstanbul, belong to a Byzantine palace. The houses inside the palace and the dense urbanization in the environs will pretty soon destroy all traces of the palace.
