ARCHAEOLOGICAL DESTRUCTION IN TURKEY

YEAR 2008 PRELIMINARY REPORT

MARMARA REGION - BYZANTINE PERIOD
APRIL - SEPTEMBER 2008

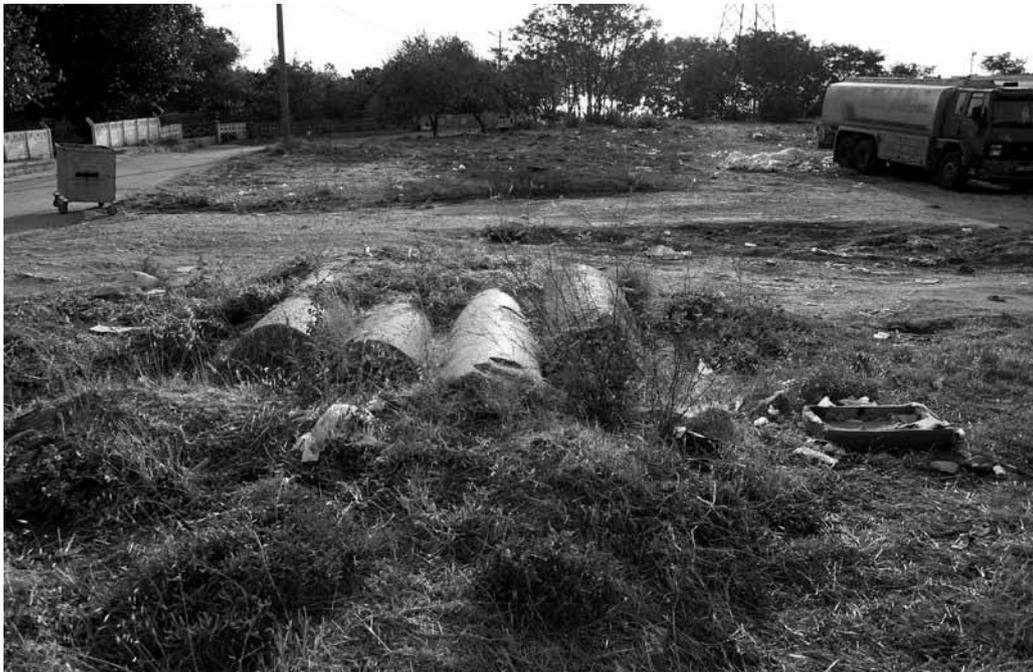
Rhegion Palace: The Rhegion Palace dating to the 5th century was a building complex that consisted of many structures. An important part of this complex was situated in the Cennet Quarter of Küçükçekmece in İstanbul. We use past tense because there are no traces of the palace at present except for four columns. The enormous land on the “Antika Avenue” where the palace was once located, clearly shows how the cultural assets get destroyed and lost from the records of history.

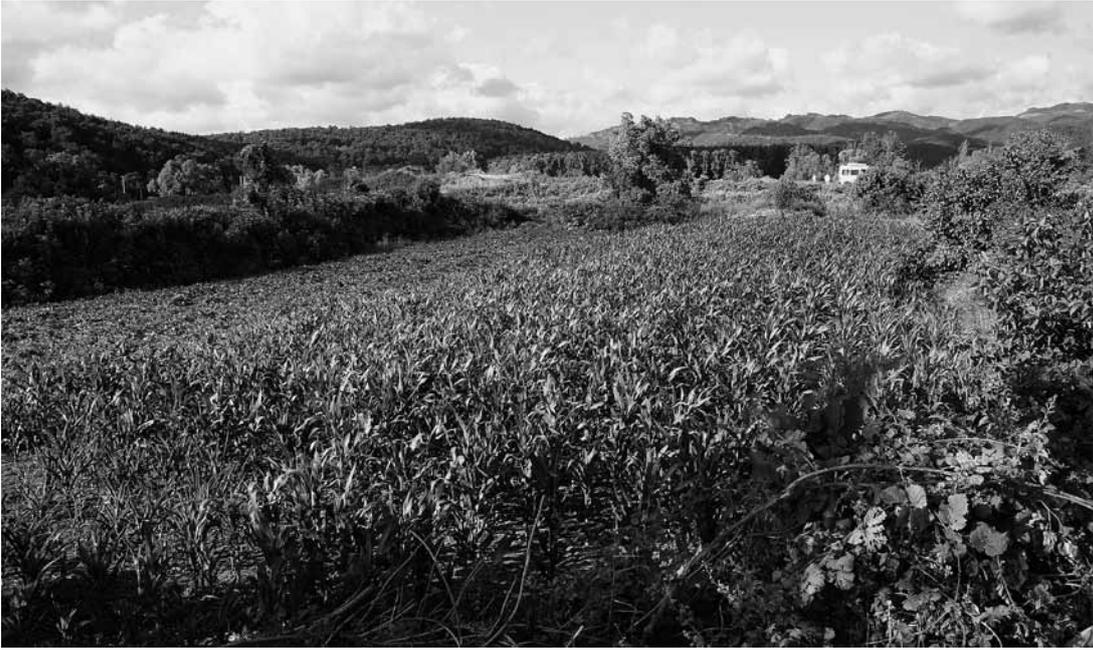
Cave Fortress: There is no fortress in this shot, you can only trace only a few irrigation canals here and there, new plantation areas, and some collapsed walls. From the Cave Fortress lying to the south of the Mağara Village in the Söğütlü District of Sakarya, nothing but only some building stones remained under the roads running over its four walls at present. This is an example of how destruction by agriculture destroyed a Byzantine fortress.

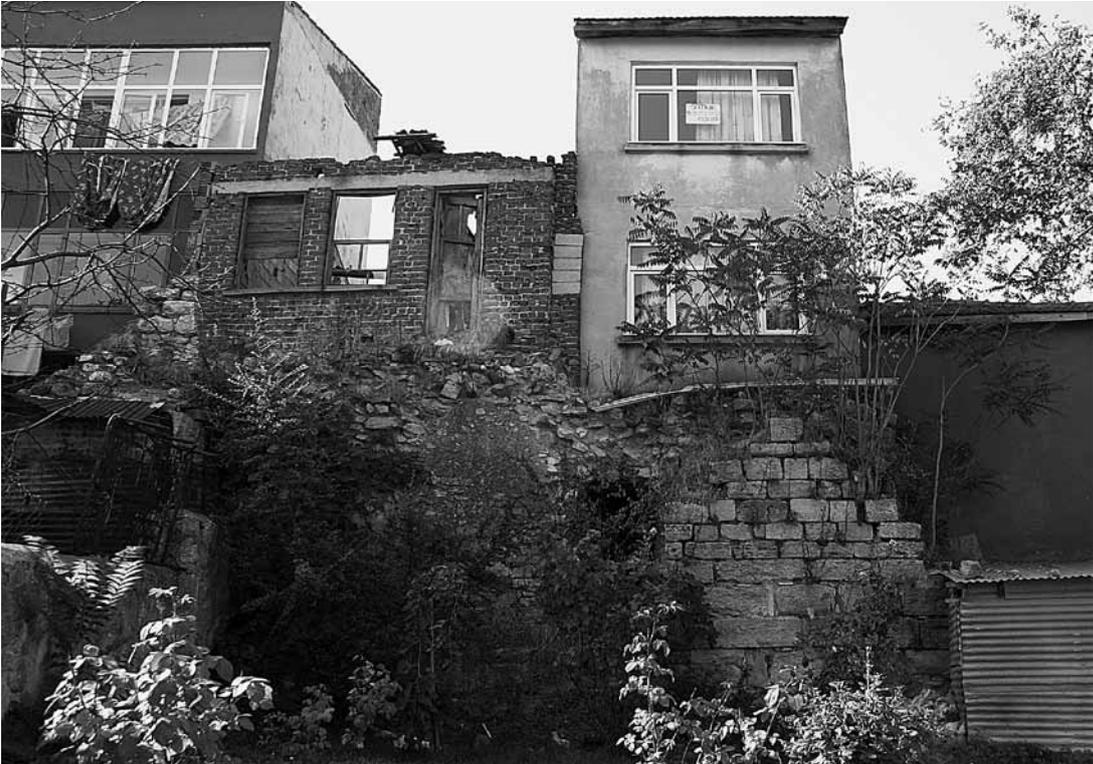
Çatalca Fortress: The fortress resting in the Kaleiçi Quarter of Çatalca has been under the threat of intense destruction resulting from urbanization and new road constructions. Who bothers for a new foundation while there are Byzantine walls all ready. Some leveling on top of these fortifications, and adding the fallen stones into the foundation; here we go, we have our house ready! Who cares about preservation anyway! In case of any hostile attack, we pull them back...

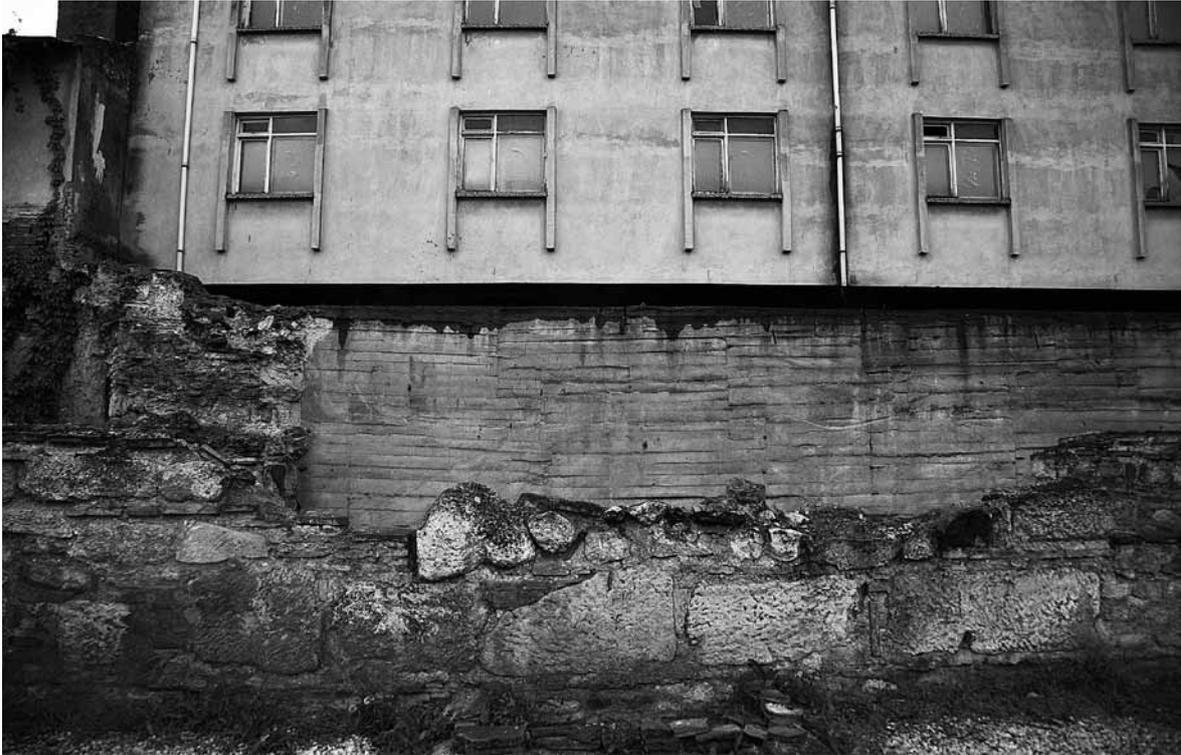
Edirne Walls: The walls which protected Edirne for approximately 1000 years from the 2nd century to the 12th century are in urgent need of protection. In fact, nothing has been left to protect. This shot portrays the modern buildings rising above the chapel dating to the 10th century, situated to the immediate south-east of the Macedonian tower, which is the only remaining structure from the Edirne walls. The chapel itself had been almost completely destroyed 25 years ago with a building constructed over it.

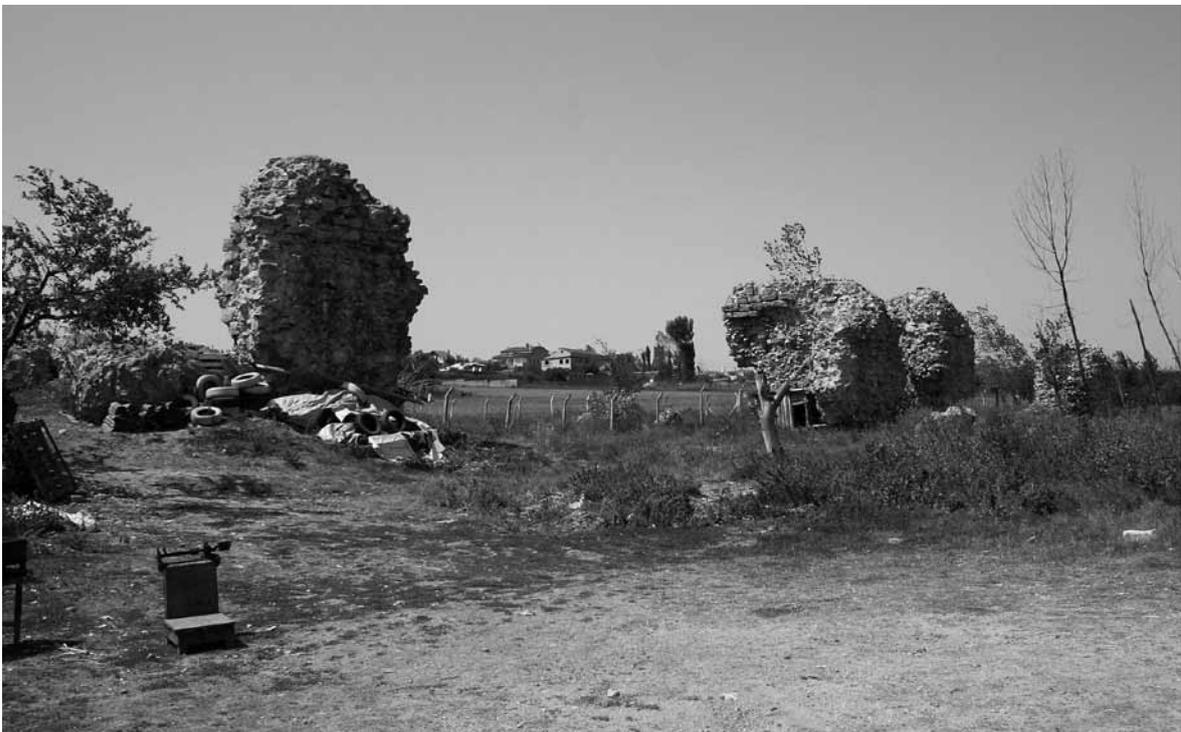
Ahmetli Fortress: The building stones of the fortress situated at Gölboyu Mevkii of the Ahmetli Village in Çatalca were used in the construction of the road. Some foundations were demolished during the construction of canals in the region. Parts of the walls can be traced inside the lake, while the bastions on the land are used as fishermen's shelter. Plenty of sherds and building elements has been scattered around.

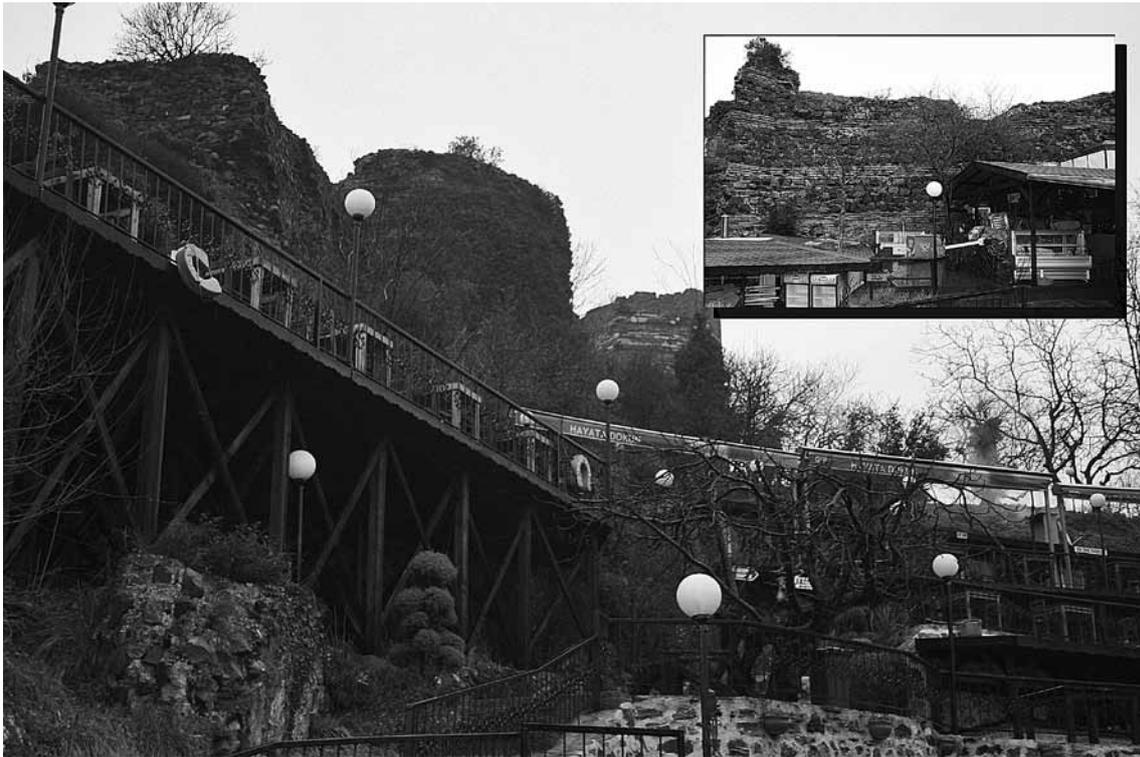
Yoros Fortress: The only extant Byzantine fortress in İstanbul dating to the 13th century is situated at Anadolu Kavağı. Therefore, it is increasingly under the threat of heavy destruction due to rent seeking opportunities in this region. Particularly the southern walls were destroyed in 2005 to be used as a tea garden and restaurant.

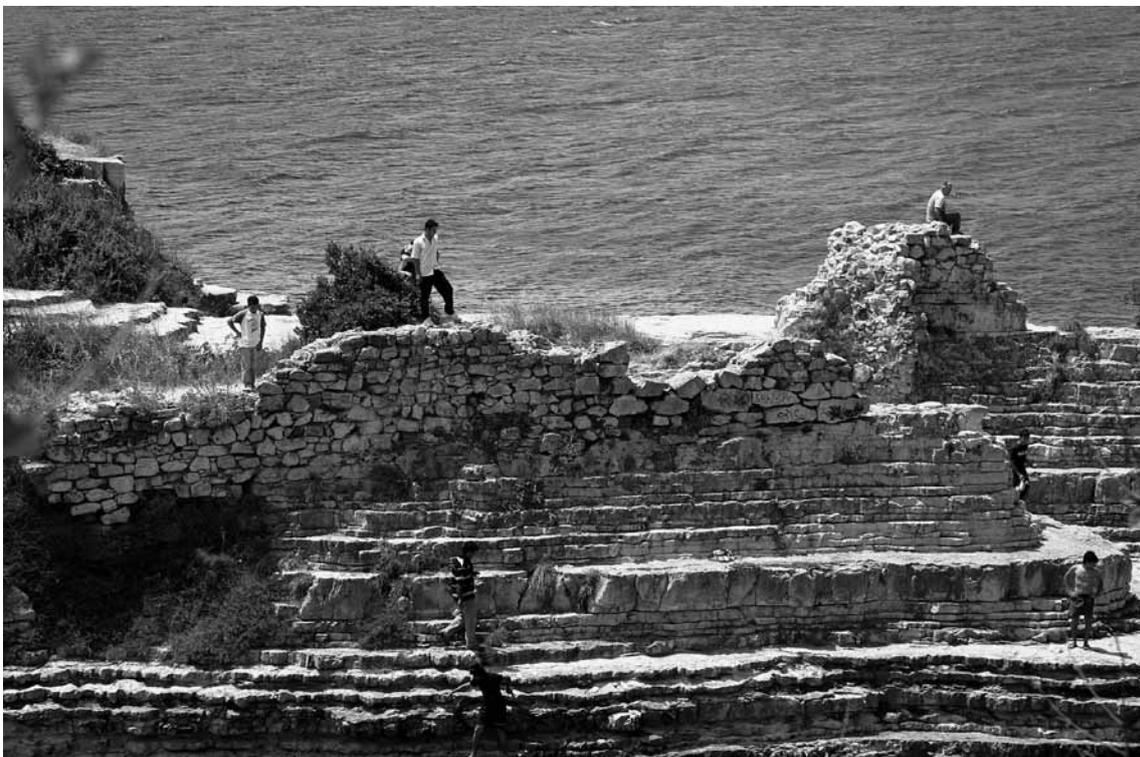
Kerpe Fortress: It rests on a rocky area overlooking the sea to the north of Kerpe in the Kandıra District of Kocaeli. Nothing was left from the fortress, in which the ancient harbor of Kerpe is also situated, except a few meters long wall and a few vacationers who go swimming from the rocks!

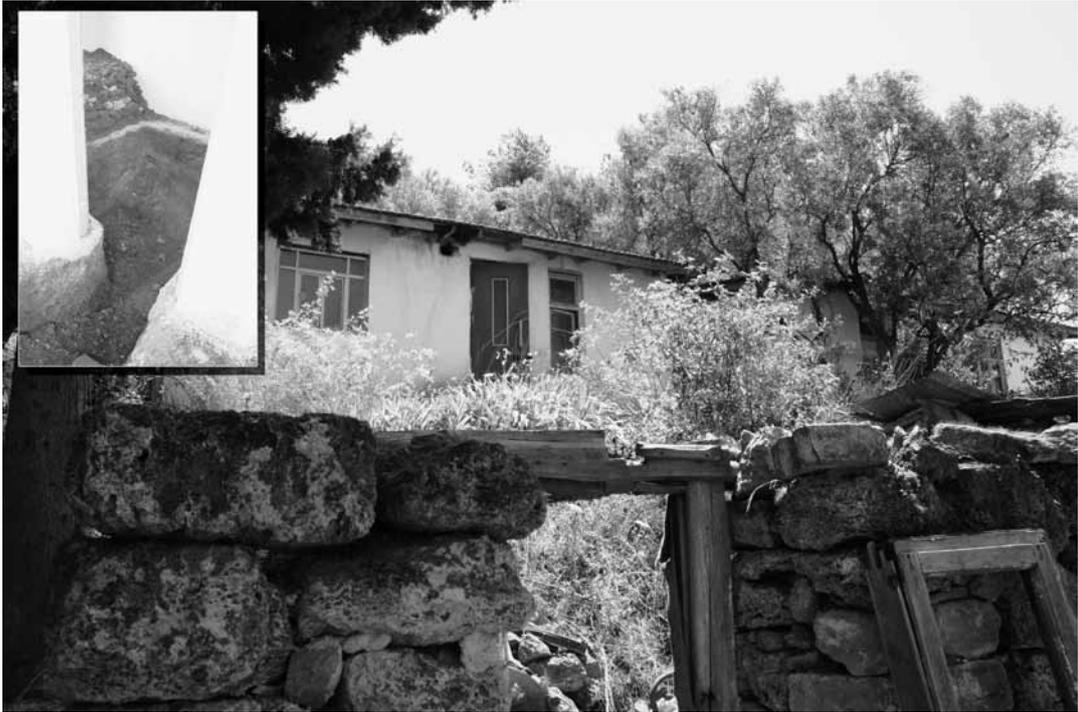
Aya Sotiri Church: Nothing remained from the Byzantine church, which was located at Kumi Mevkii of the Zeytinbağı Town in Mudanya. The church collapsed completely, and a concrete flimsy house was built upon it. The people who constructed the building were also involved in a number of illicit diggings around and inside the church. Now, deep pits dug by treasure hunters are observed inside the building, which has been already abandoned.

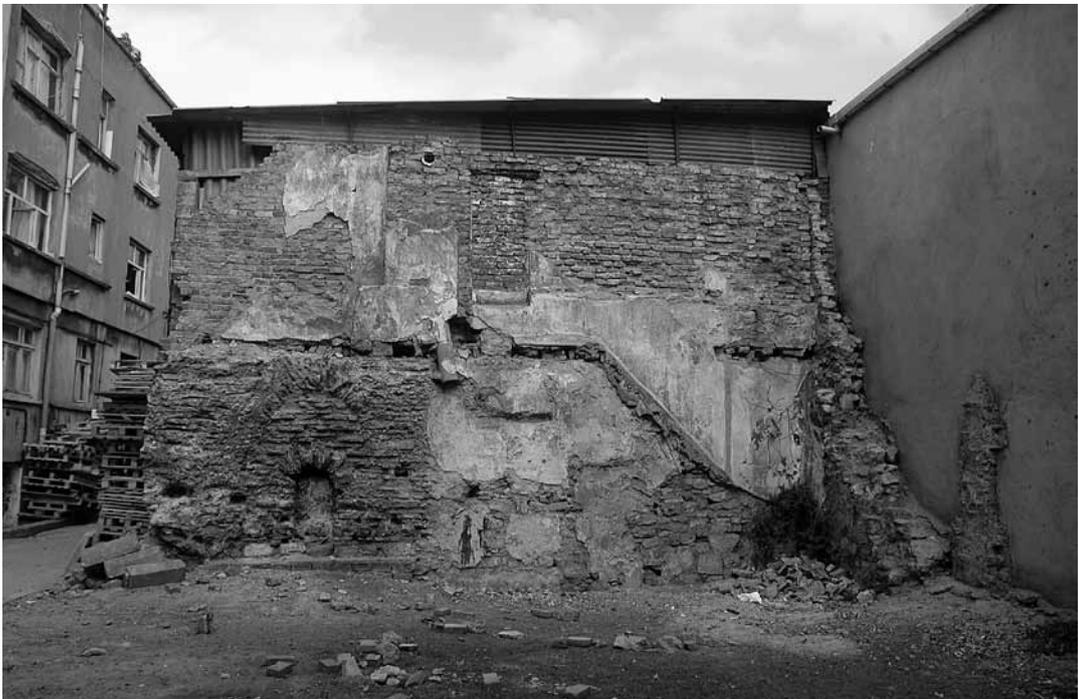
Ayakapı Chapel: A building and a log storage were built above what was left from the Ayakapı Chapel, which was dated to the 11th and 12th centuries (situated in the Ayakapı Street of the Abdi Subaşı Quarter in Fatih District). The apse of this small church, where the priests offered their services, now can be seen through the piles of logs inside the store. We have seen churches converted into mosques, but this is the first example of a church converted into a timber shop...

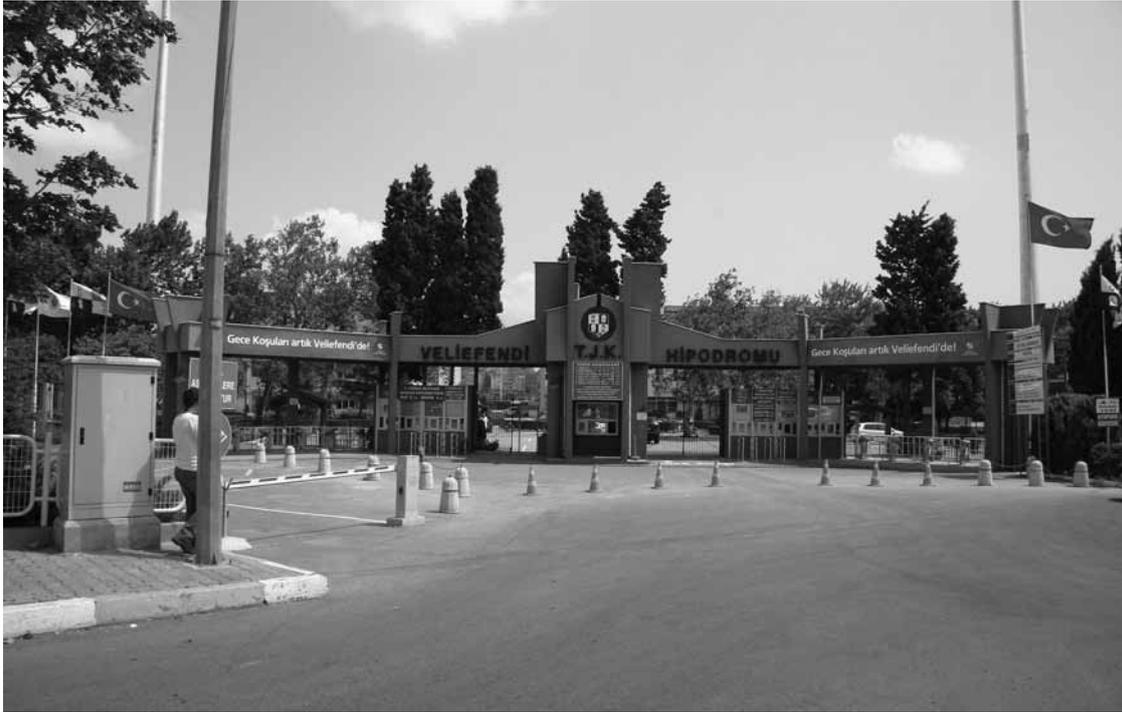
Veliefendi Hippodrome or Campus Tribunalis: Campus Tribunalis was a famous Byzantine structure complex, famous with its swimming pools and baths lying on a very large piece of land. This area which was built by Emperor Valentinian I in the 4th century had stepped seatings called tribunal. This unfortunate area was also a camping site for the Byzantine army before and after a campaign. It is currently being used as Veliefendi Hipodromu. That means, where Valentinian I saluted his armies in the 4th century, now the bets are on horses...

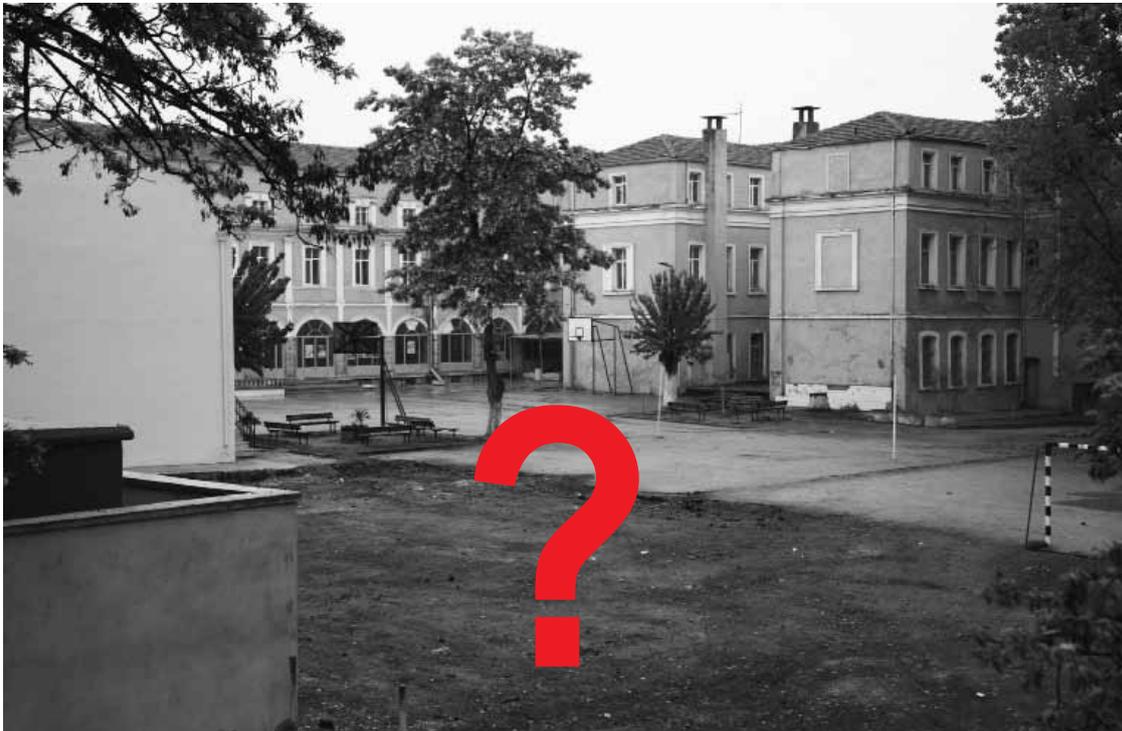
Ayasofya of Edirne: Courtyard of the old warehouses of the State Monopoly, now the Murat I High School in the Kaleiçi Quarter of Edirne. It is known that once the church of Ayasofya was rising in that courtyard. And now it is completely “gone with the wind”...

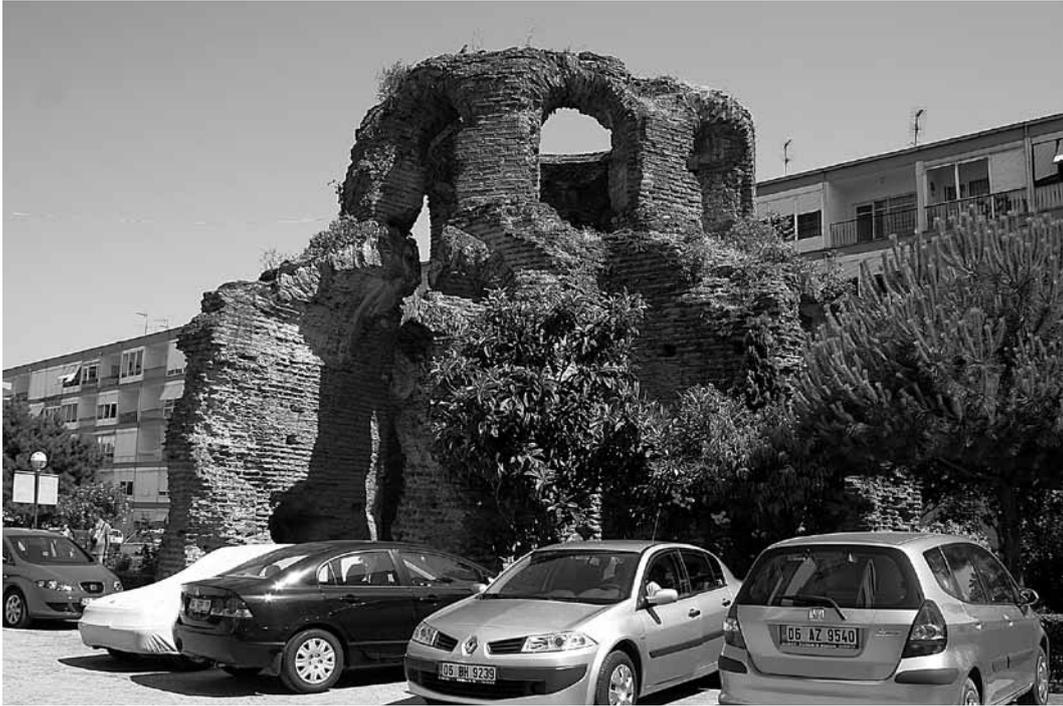
Kara Kilise: It represents a very important example of the Byzantine architecture with its masonry consisting of solely bricks, from the Early Byzantine Period. It is situated at the Başkent Summer Resorts 1 in the Sahil Quarter of Çiftlikköy in Yalova. Lying in the middle of the recreation center which is in the service of inhabitants and vacationers, it survived many destructive earthquakes, but looks helpless against the harm human beings can give.

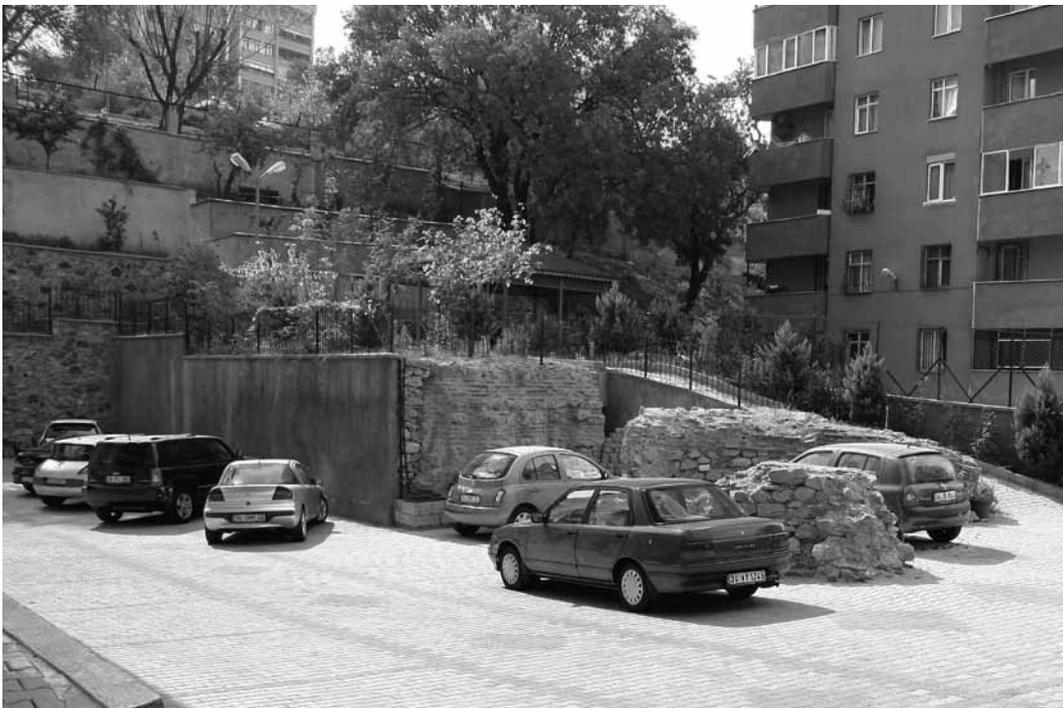
Building at Merdivenköy: The monastery remains at Merdivenköy in the Kadıköy District of İstanbul are currently being used as parking lot of an apartment complex built in 2005. Forget its authentic identity, it is now nothing, but an element of landscaping. The major part of the structure was destroyed during the construction of this building.

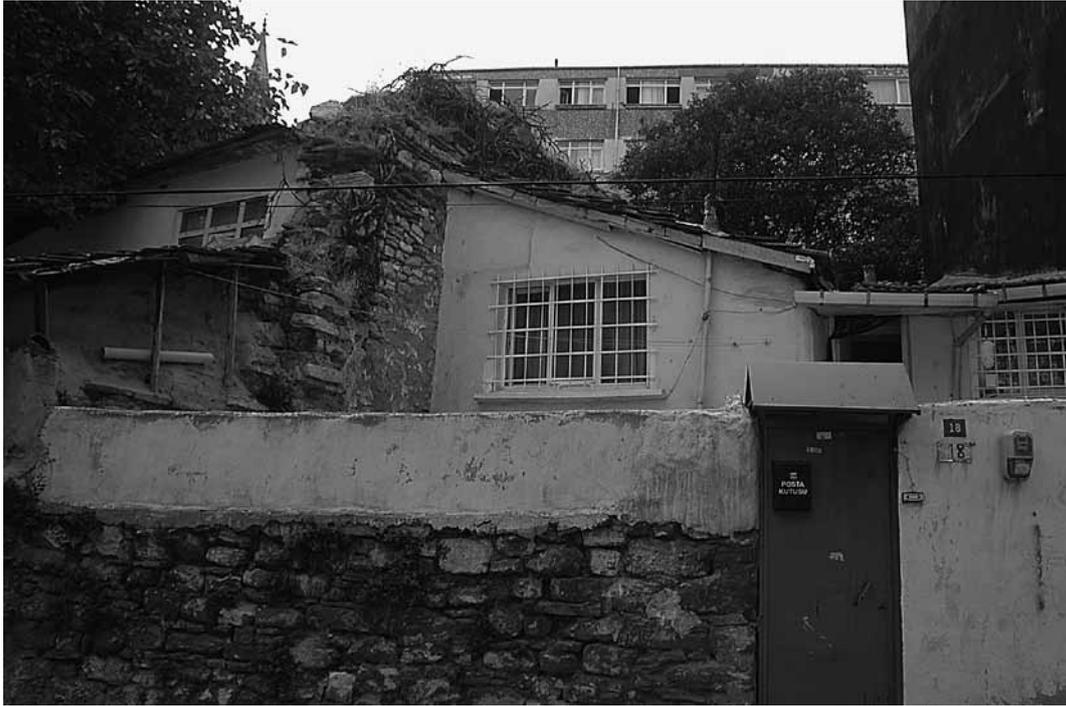
Odalar Mosque: Almost no remains are available from the building situated at the Karagömrük Neighbourhood of Fatih District. Being used until a fire in 1919 with many modifications, it was considered as an important artifact representing the Byzantine architecture as well as wooden architecture of the 19th century. As of today, only some walls can be seen among the houses on the Kasım Odalar Street.

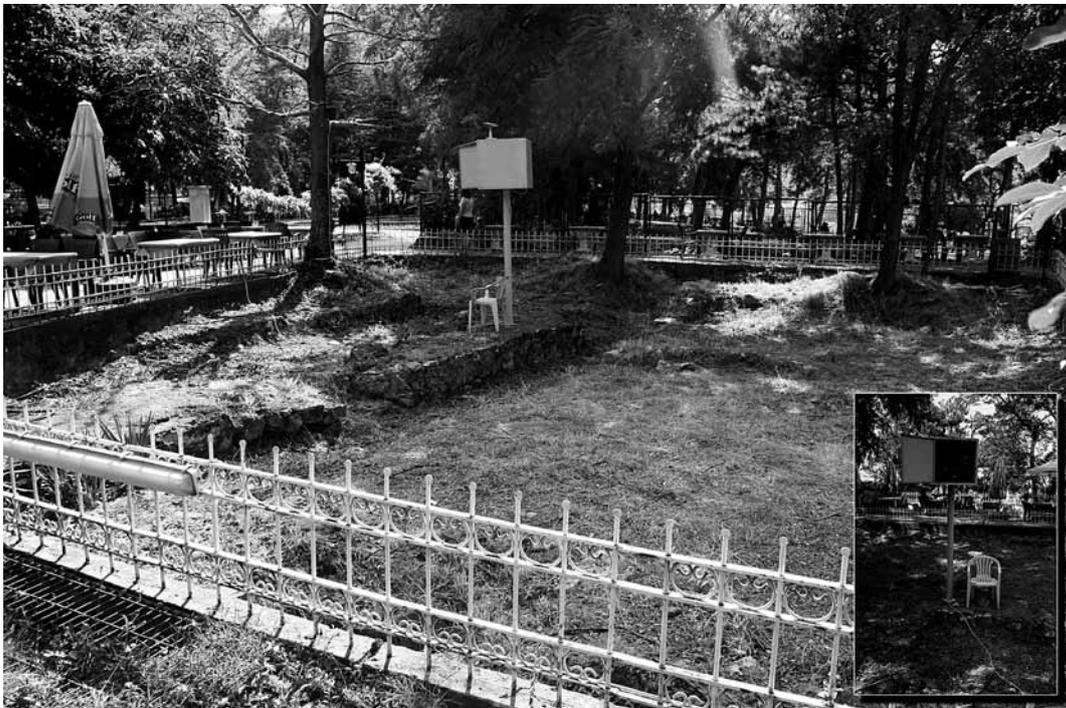
Osmangazi Building Complex: These building remains which were unearthed during a campaign by the Bursa Museum in 2000, are situated inside a public park at Hisar in the Osmangazi District of Bursa. It seems that the nice Bursa view from the park was not enough, so the business owners decided to place a TV set inside the tea garden, which was installed by hammering a steel support inside the 1000 years old walls...

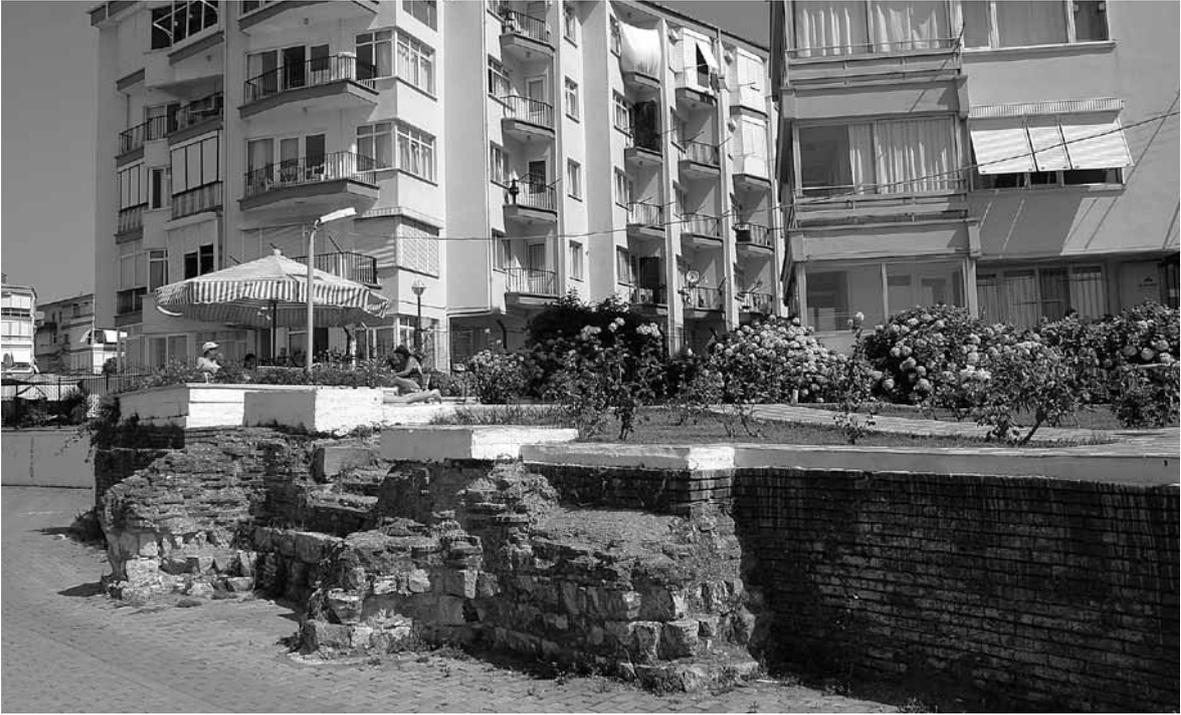
Pylaea Fortress: Based on the resources, the Pylaea fortress was built by Emperor Manuel Comnenus in 1145. What remained of the fortress' harbor at the Huzur summer resorts in the Çiftlikköy District of Yalova can be seen in this picture. The enclosing walls of the summer resorts were seated onto the fortress walls. It is known that the fortifications were destroyed during the construction of the resorts. Usually preferred by vacationers looking for peace in summer, these resorts gave no rest to the 900 years old Pylaea fortress.

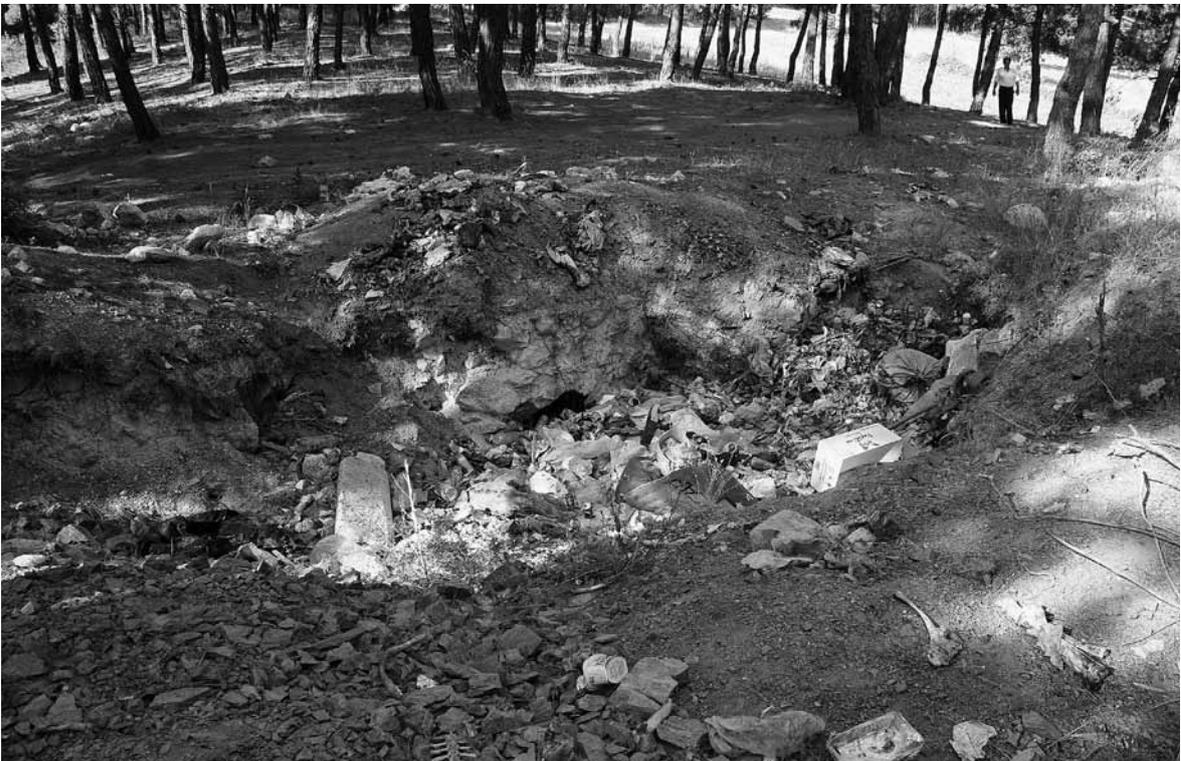
Theodoros/Tahtalı Church: What survived from the church situated just out of the Tahtalı Village to the west of Bursa is a large pit, full of garbage. Many building elements are scattered around the church, situated in the middle of the wood, and many pits are observed in the vicinity due to illicit diggings.

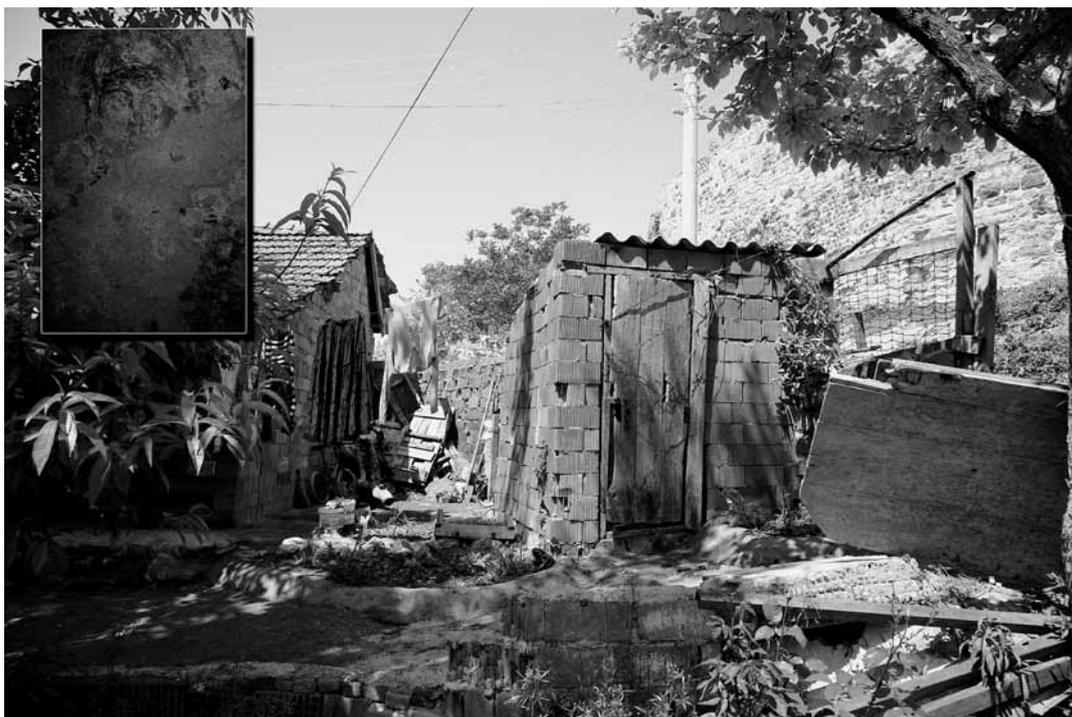
Triada Chapel: This cave which had been inhabited since the Hellenistic Period was also used as a subterranean church during the Byzantine period in the 14th century with its own cemetery. This impressive chapel, with plenty of frescoes on its walls, is accessible through a flimsy cottage in the garden of a house at the Gazi Ömer Quarter of Enez District in Edirne. The description of St. Mary carved onto the rock witnessed numerous illicit diggings, waiting for a hand to reach her along with the skeletons exposed during these illicit diggings.

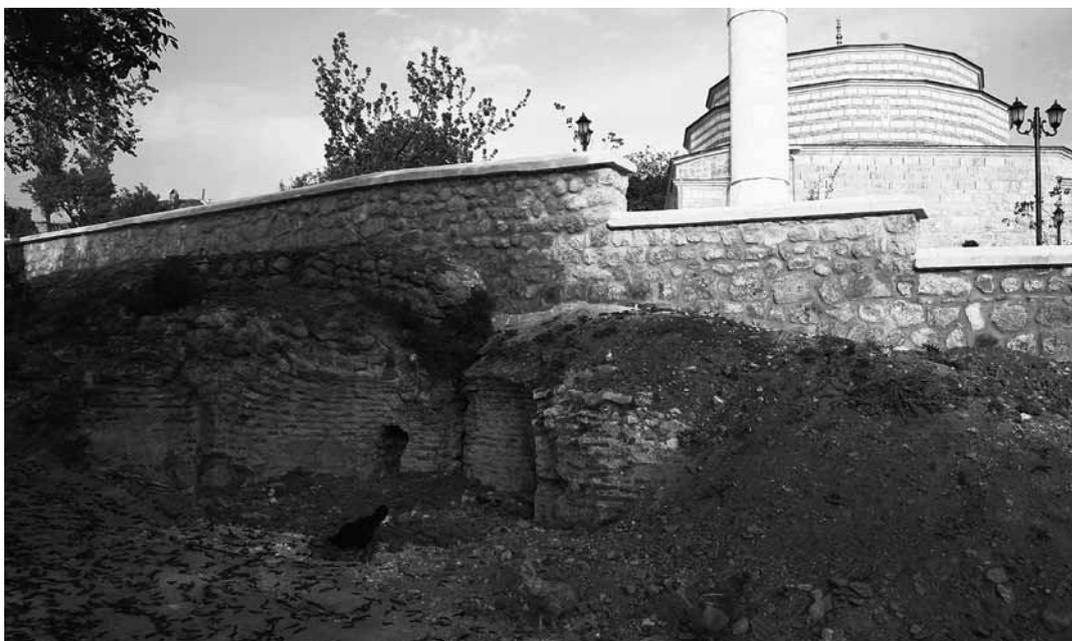
Tetraconchos of Vize: It is believed that the tetraconchos, i.e. four bays in semi-circular plan covered by a half-dome and added symmetrically onto a central bay, was used as a baptistry or martyrium (monumental building above the graves of religious martyres). This tiny structure is situated next to the Şarapdar Hasan Bey Camii in the district of Vize at Kırklareli, and a major part of it has been destroyed, some parts extending under courtyard wall of the mosque, and the remaining parts used as chicken coop.

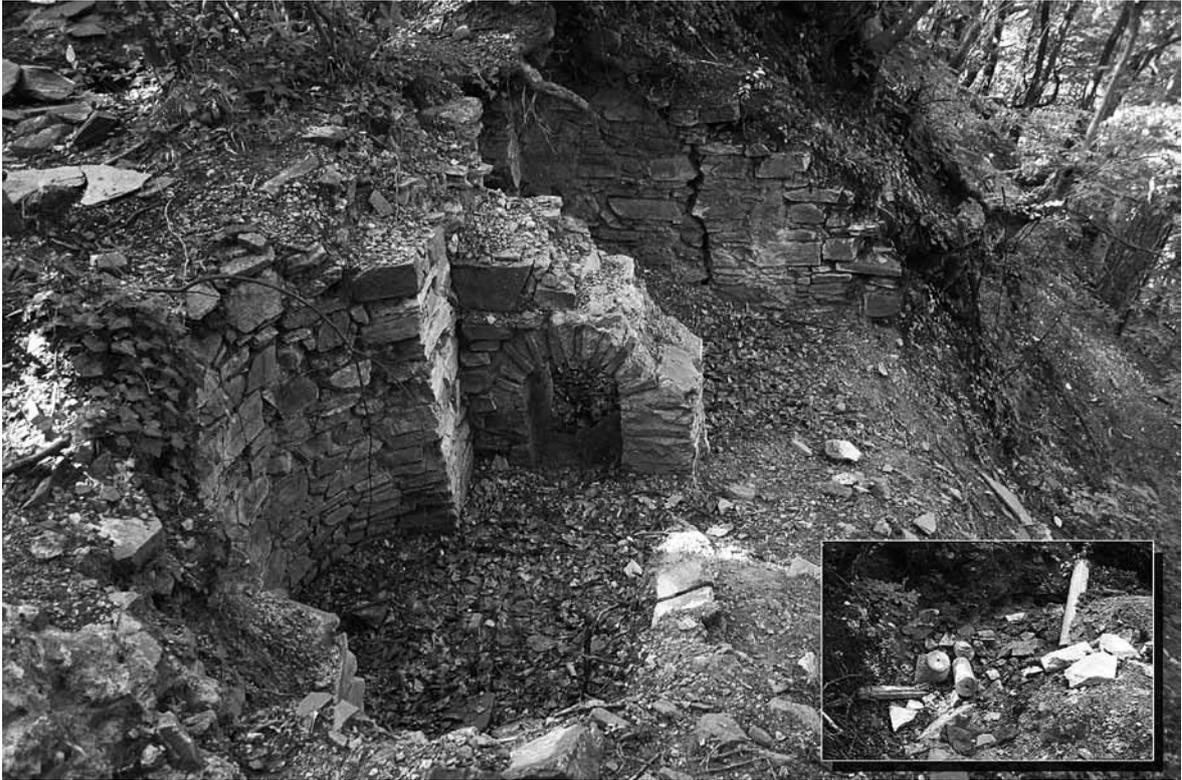
Yurtyeri Monastery: The remains situated at Cumalı Kızık on the skirts of the Uludağ mountain in the Yıldırım Quarter of Bursa probably belong to one of the many monasteries well-known in the region. No systematic survey has been conducted at the site yet. The structure and its building elements had been completely shattered by the thieves, and the eastern section disappears gradually towards the Balıklı stream due to landslide.

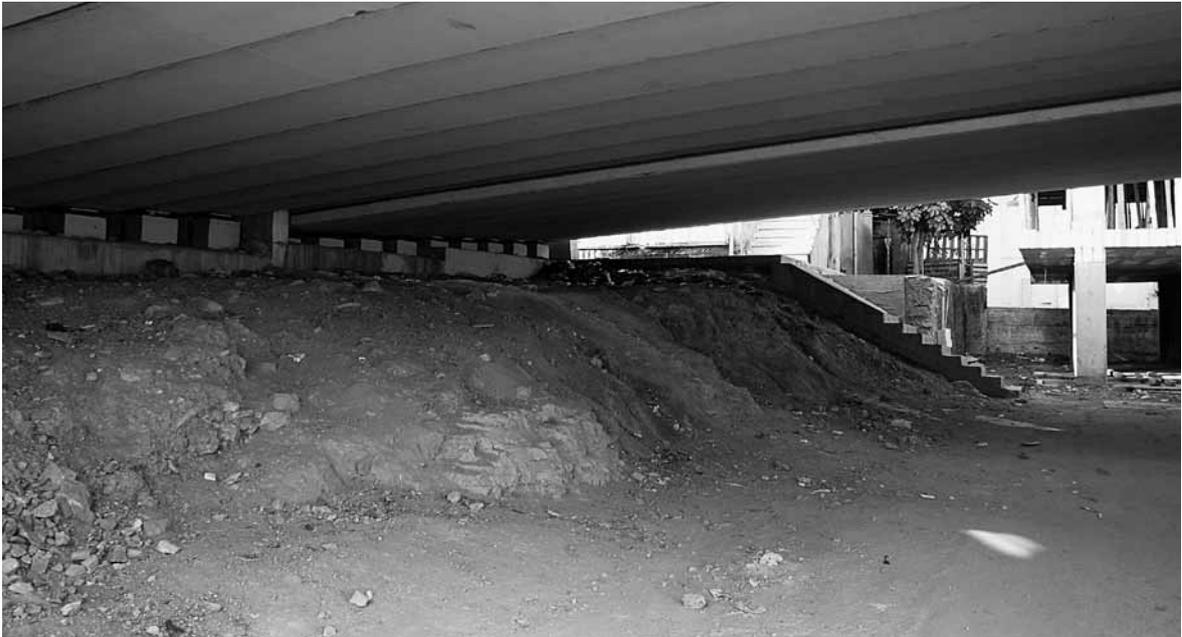
Pendik Monastery: A very important Byzantine structure excavated by the İstanbul Museums of Archaeology between 1973 and 1975: Pendik Monastery. Even registered! The monastery which is situated at the intersection of the Vişne Street and the Çınardere Viaduct while driving from Pendik to Kurtköy, almost disappeared under the apartment blocks which are still under construction and the viaduct which was finished between 1995-96. Here is the Pendik Monastery!

Destruction by housing and road constructions is most common in Istanbul. Unfortunately heavy destruction by contemporary buildings and roads in the city centers of Kocaeli, Bursa and Iznik have also been observed in sites, which had been systematically excavated in previous years. One of the most striking examples of such destruction is the monastery in Pendik. Located at the intersection of Visne Street and

Çinardere Viaduct leading from Pendik to Kurtköy, a major part of the monastery, which was excavated between 1973 and 1975, has been already obscured by the viaduct constructed in 1995-96, and some ongoing constructions for apartment blocks in the neighborhood. The walls of Istanbul represent another striking example for destruction by housing and road constructions. A major part of these walls, **where almost all types of destruction factors can be observed**, will be destroyed without leaving any trace (The Edirnekapi and Topkapi sections vanished during the construction of Adnan Menderes Boulevard and Millet Street, and a major part of the sea walls had been demolished during the railway constructions starting from the 19th century. Intense housing is observed on the Blachernae Palace and many sections of the sea walls. As part of the natural destruction, almost all sections of the walls are under the threat of trees, some even being collapsed. The ditches, first step of the defense system on the Yedikule section of the walls are presently used as vegetable gardens. The historical characteristics of the walls have been lost, particularly due to recent controversial restoration works. The humongous screen in front of the Golden Gate in Yedikule, veiling the gate is a good example of thoughtless modern use. The land walls of Istanbul have been damaged not only as a result of failing to preserve them as required, but also of making erroneous interventions although the walls are inscribed in the World Heritage List by UNESCO under the title of Historic Areas of Istanbul.

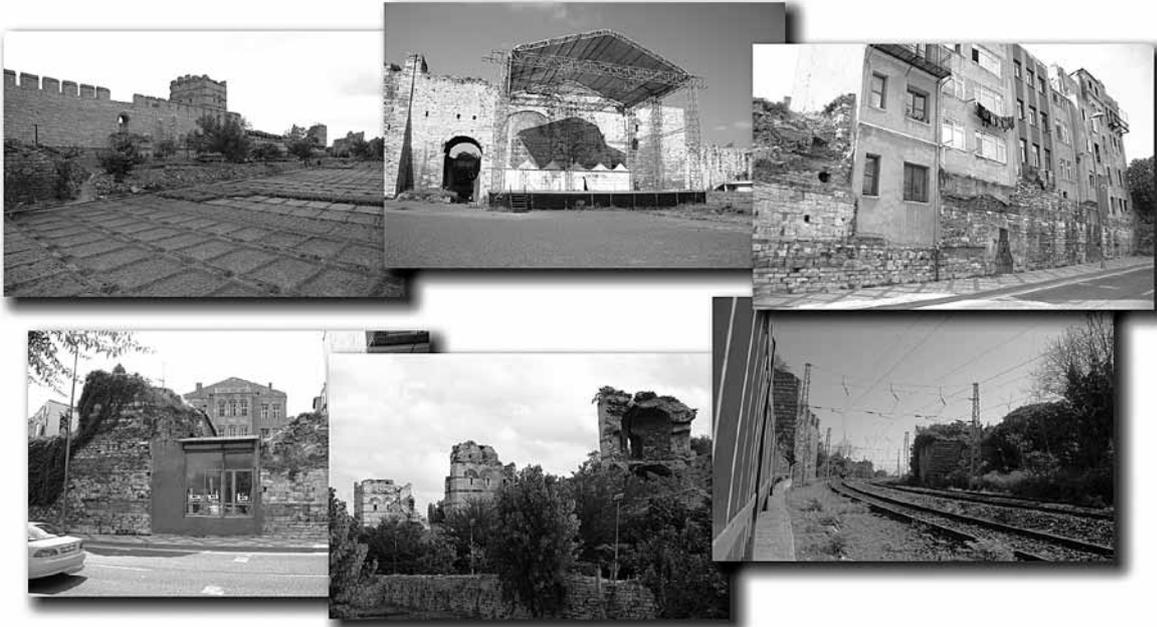
Istanbul Walls: All destruction types are visible on the Istanbul walls: Since some sections just “took off and flew away” during the construction of the main roads near Edirnekapı and Topkapı, and some other parts on the seaside “were taken away” during the construction of railways, nothing can be done anymore to save these. And we are all familiar with the unskillful fictitious restoration implementations. Housing seen almost everywhere now became an ordinary part of the walls. The trees that grew on the walls and the plantation fields around add to the momentum of the destruction process. The attack against historic assets is being poorly hidden by a humongous performing arts’ scene veiling the Yedikule walls, however it is far from concealing the horrible destruction on the 21 km long walls...
